# Photo report wi\_8\_f\_2500\_Tripp 2

## 2015 Angola HPW

Photo Report 07:06. / 06.23.2015 "Hans-Peter Widmer"

### 1. Mega Bore CNC lathe

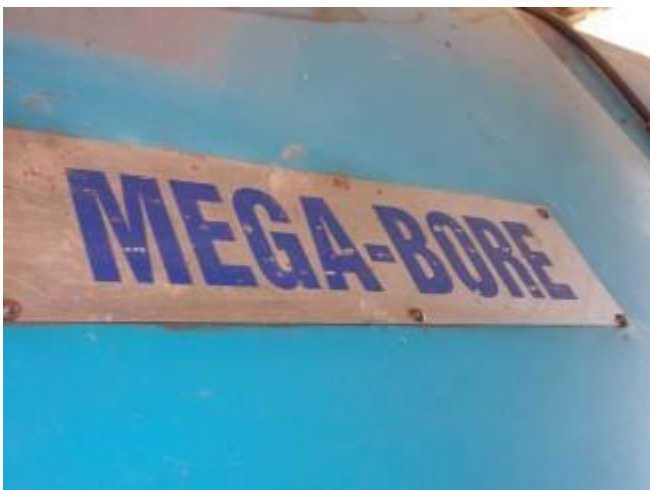
P1: The CNC Lathe Bore Mega strike again. Transmission does not go.

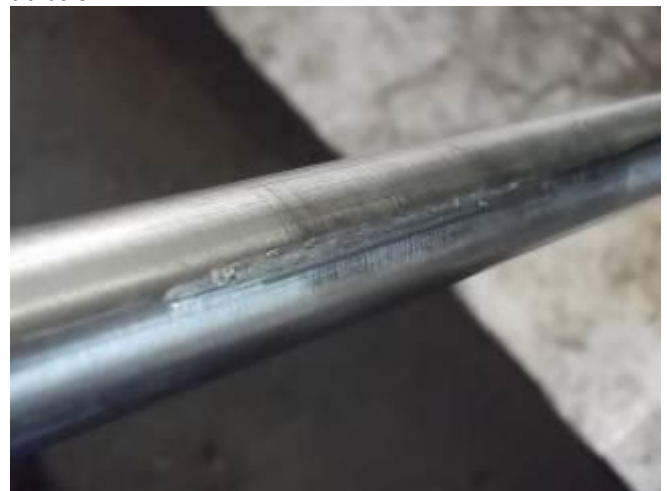
P4. A shaft on which the shift fork runs, has eroded. Unfortunately, the material pairing steel on steel was chosen. It gives only a friction of 0.01 with n oil. But there are no lubrication holes. So there is a risk to eat. If brass or PTFE bushing in there, it would also not dry can chew.

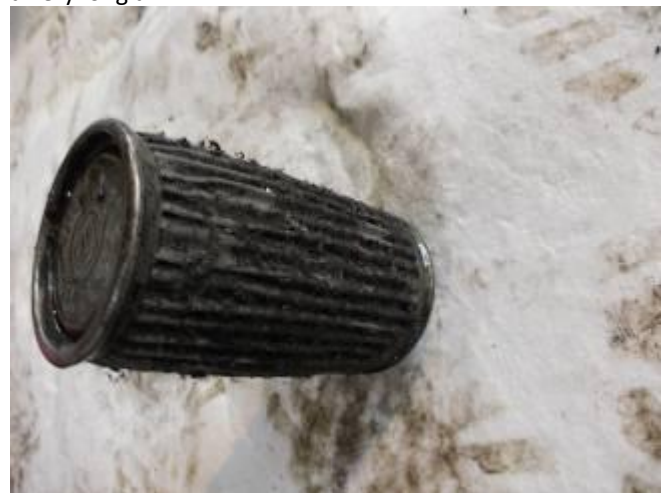
P10: Why the abrasion because in it, we did not recognize.

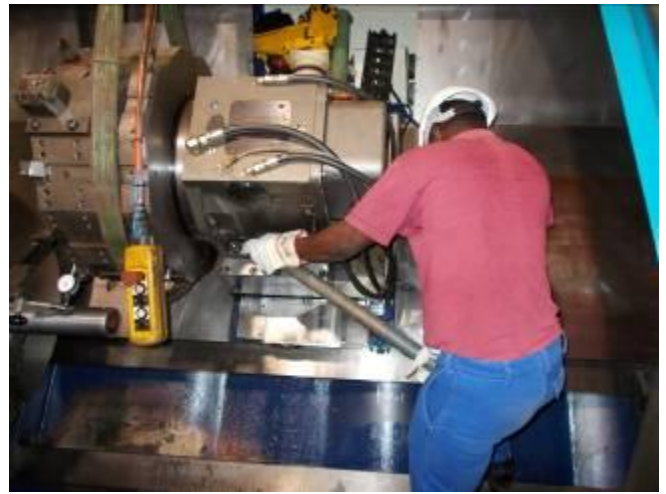
P15: The turret of the Mega Bore was inclined to 100 mm travel 1 mm. So again a big crash.

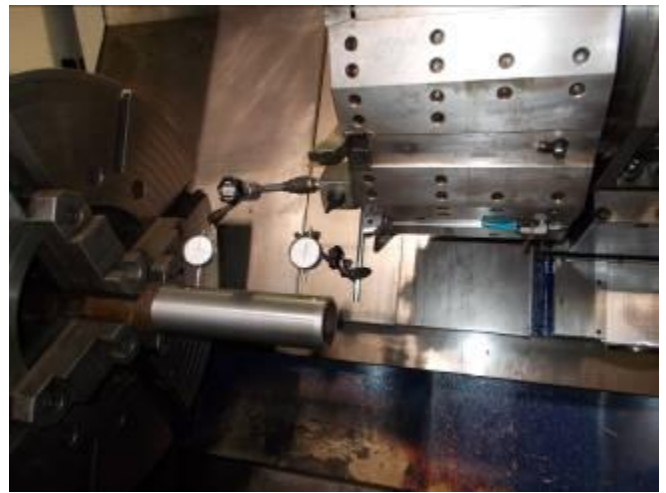
P16: The headstock was 300 mm 0:17 mm diagonally. Very complex align the headstock at a slant bed lathe.

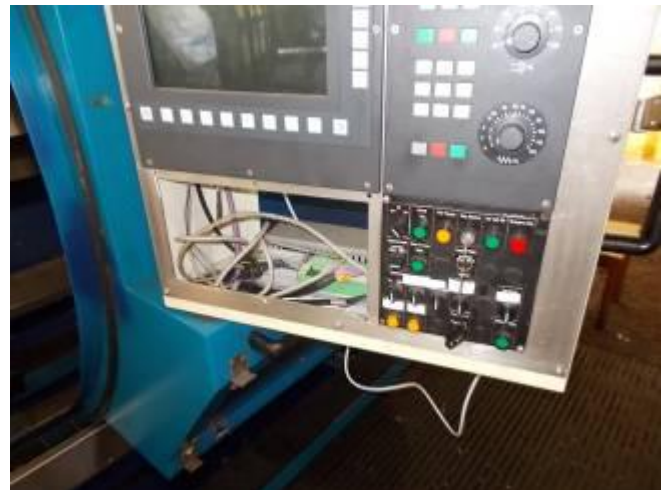
P21: Yet another keyboard at the Gurutzpe is defective. It always freezes the CNC a. The letter S cheated.

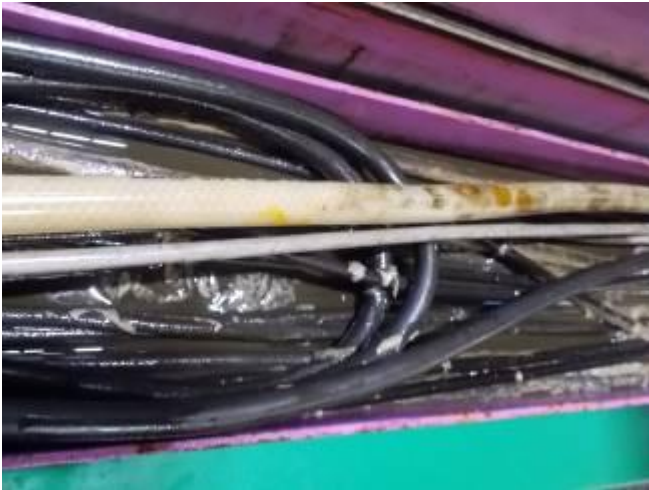
P22: A water hose rupture in the energy supply was a big mess.

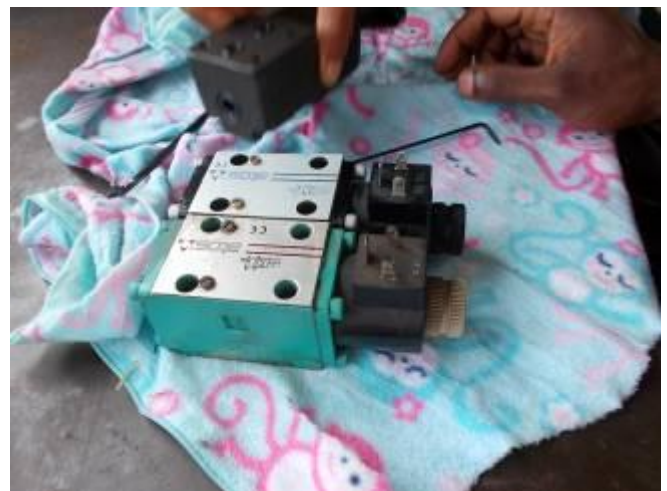
P29: The machine does not move. The valve was replaced. That was not the problem.

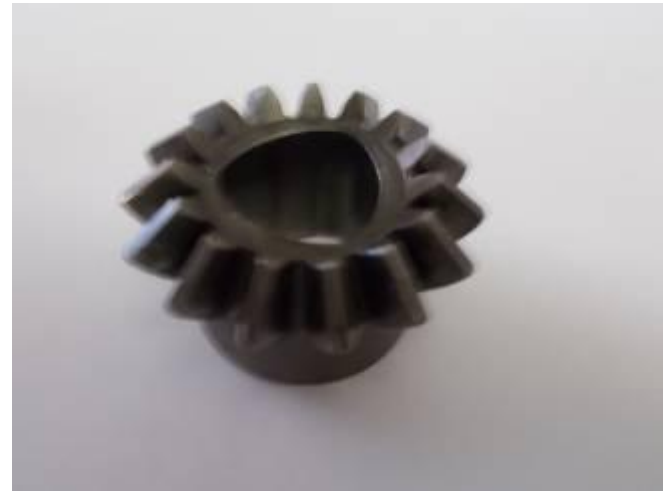
P33: For a polygon gear was broken. It had to be found in Europe. Offer received for the spare tire

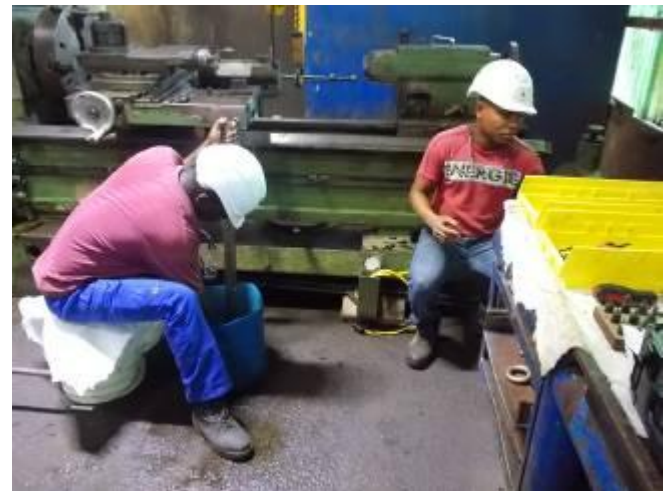
P34: A gear is broken in the Niles lathe

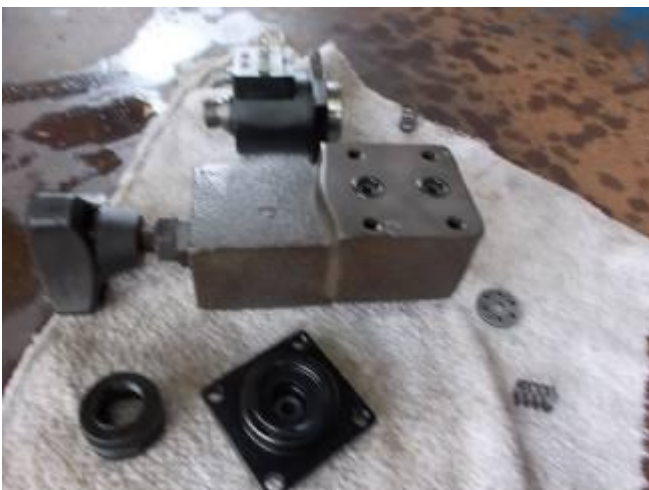
P32: The pressure controller was in the purification. It was then a slide in the hydraulic block jammed.

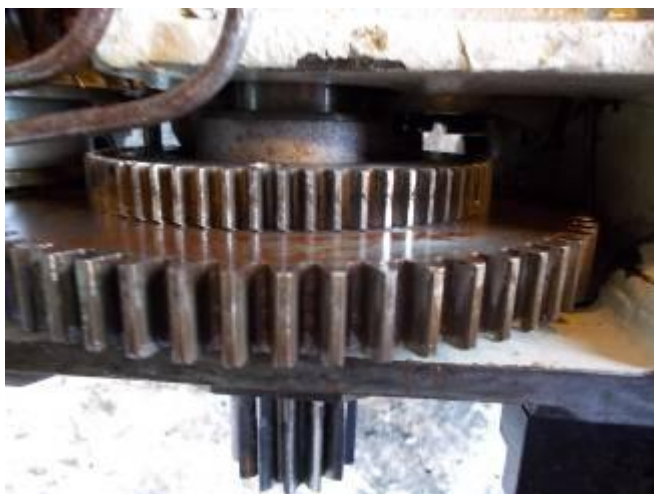
P37: The defective wheel, the smaller, the more teeth are broken. Was welded and repaired. Unfortunately not good enough. The old module was chosen wrong because the break anything so deformed that it could not be determined correctly. When the gear was worn with the dividing head, teeth were once with too little, then again with too great a distance.

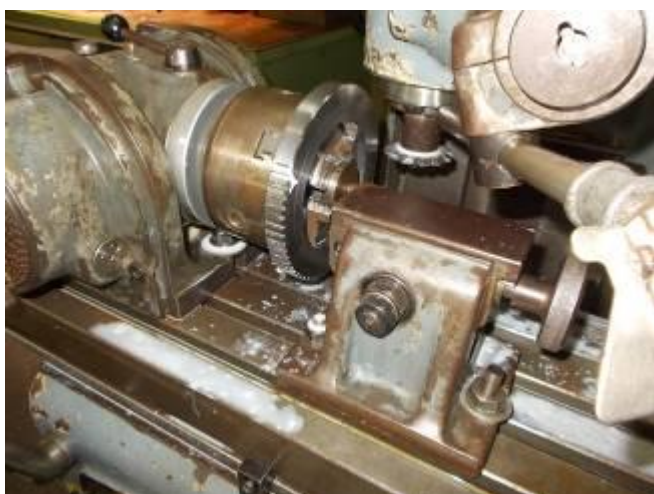
P38: the large gear is re-established. Unfortunately, with the module 2.5 mills, instead of the 2 module cutters. Here we have to gear training with the machine people. They do

not know that the diameter divided by the number of teeth, +2 teeth, the module outputs.

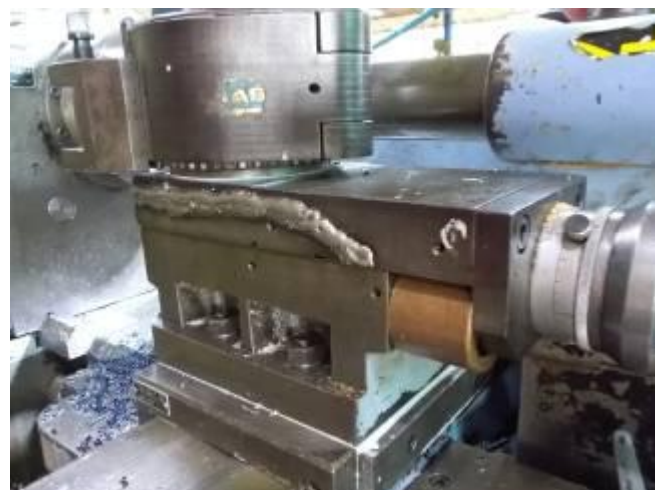
P40: At the Storebro 260 GS the top slide is broken. Make a new one. Organize cast iron.

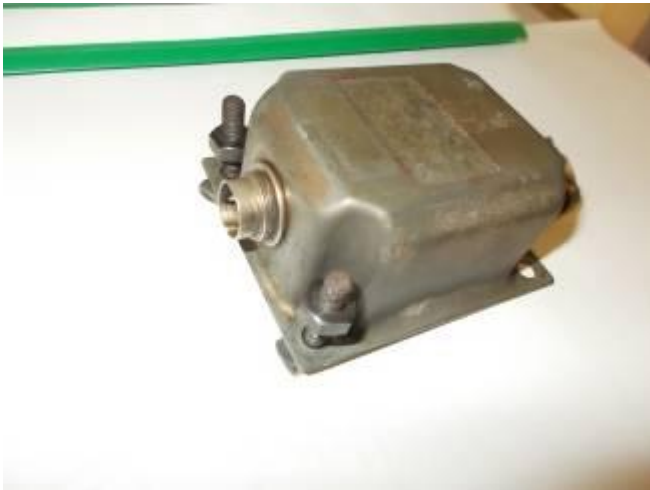
P41: For Oxycut the igniter is defective. New sought. Offer available for order.

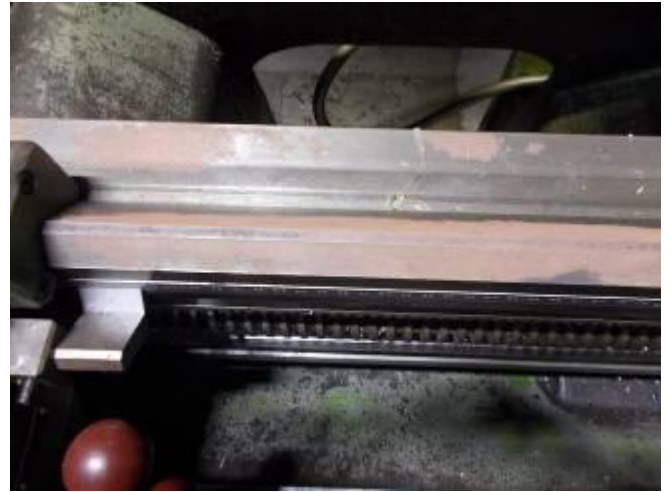
P50 Short look away and everything is rusty. The surgeons always think the maintenance is responsible. They themselves are too lazy. It's too much work and the machinery maintenance has too few people.

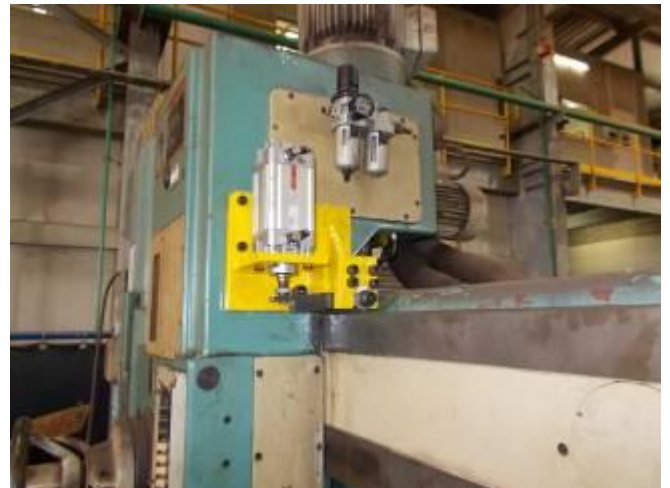
P51: At this drill is a brake outside in cultivation. The original brake is inside. Several times a disassembly was required. Since everything had to be dismantled. Always stop for about 3 days. Now peace will be.

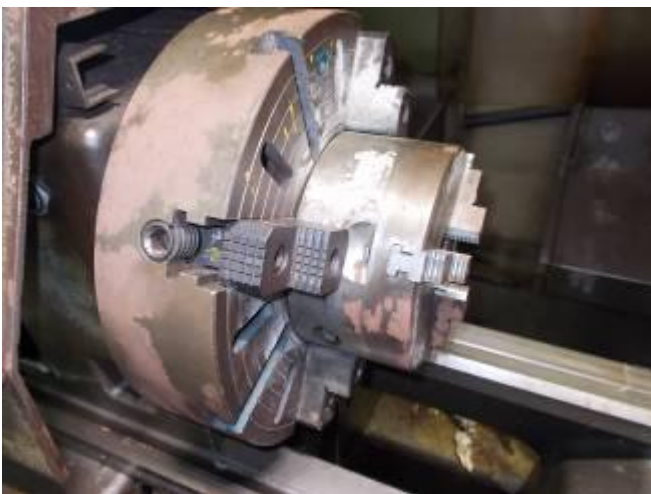
P49: The rust, the permanent enemy

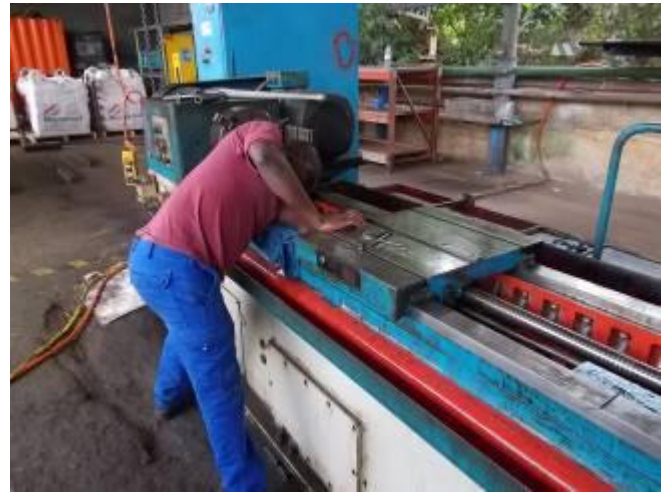
P60: The deep hole drilling machine "TBT TIBO" lost per day several liters of hydraulic oil in the working oil. It had to be dismantled 2 sled. Doing some maintenance work could also be made equal.

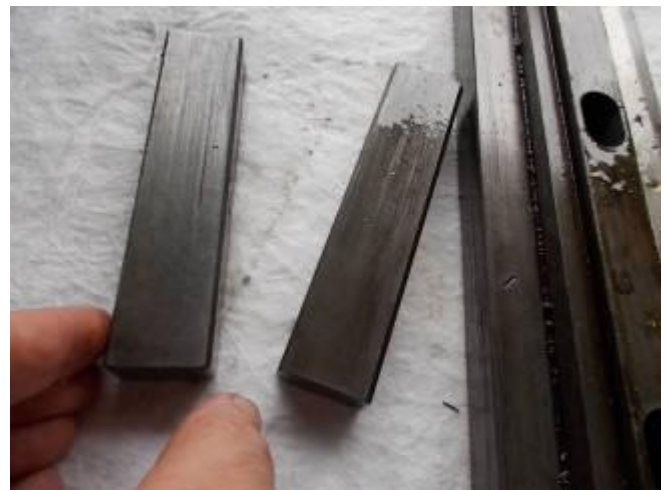
P62: The contact grips are not scraped, just milled.

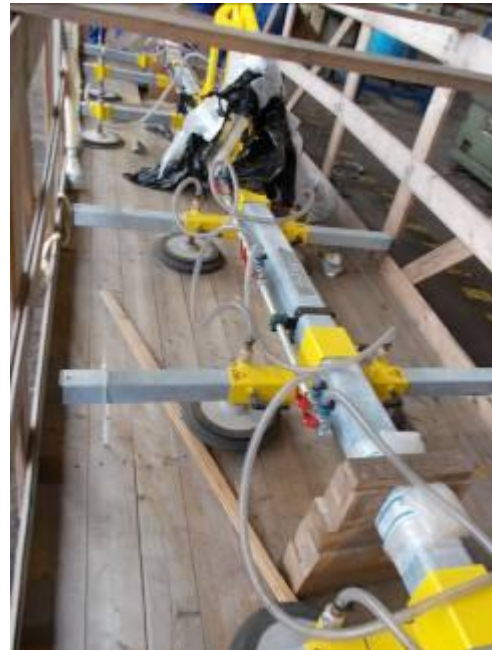
P60: The transport box was damaged. The manufacturer has not much considered when installing the package.

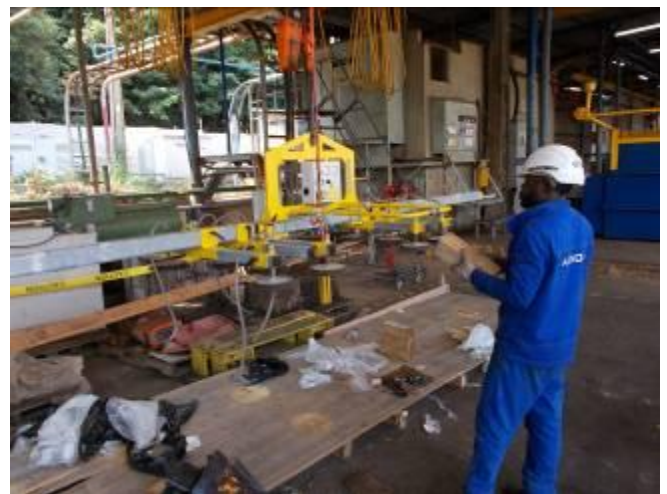
P61: The wooden floor is broken through. The suction cups standing on the ground. That was not the goal of the package.

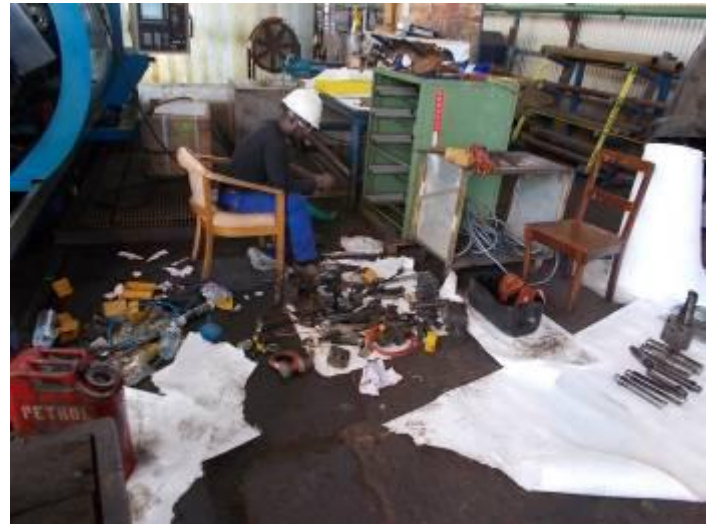
P66: The shock! These drawers we cleaned up a few months ago. And again as a mess?! Angola has a problem with drawers

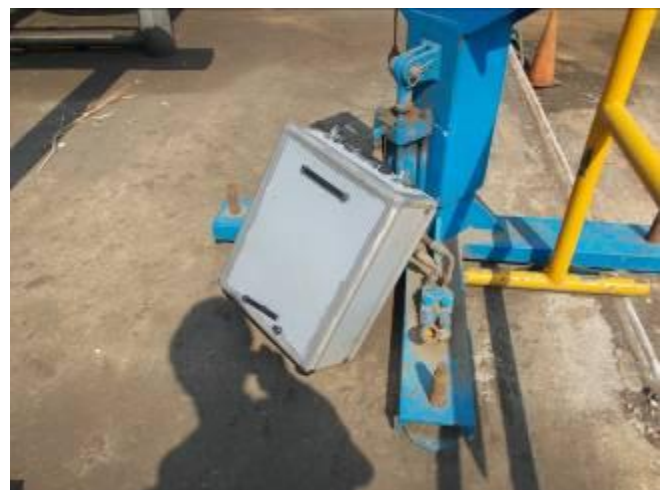
P78: Tool box. Alberto here with a new toolbox. Since 2 weeks in use. Exactly 2 weeks now, then he has fallen apart. No good quality tool. No good quality tool case. Those who work every day with tools, requires good tool.
