Picture report. Angola Trip1 - 4, 2014. report Summary

Conversion CNC lathe Mega Bore

Title: WIAP maintenance program
MEMV of everyday life report

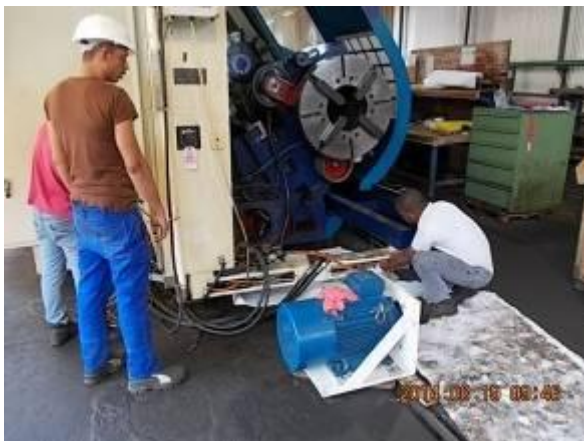
Image 1)A hole in the casing of the Mega Bore CNC machine has caused water damage. The roof was leaking. The Fanuc 18i was thereby significantly damaged. It was so complicated that we decided to replace the control with a new Sinumerik 802 D. A two-time repair by Fanuc Switzerland was unsuccessful.

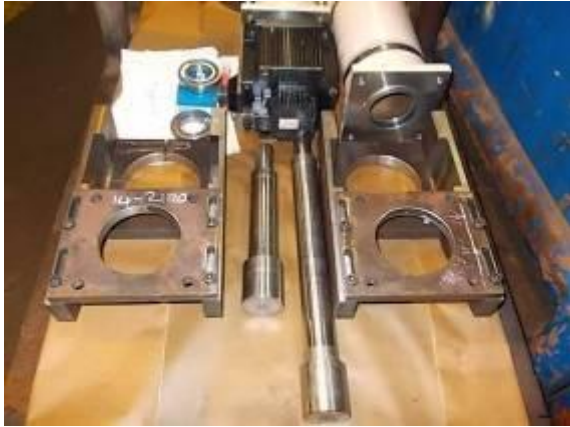
Image 2) The material, which we internals axis for the X- and Z-.

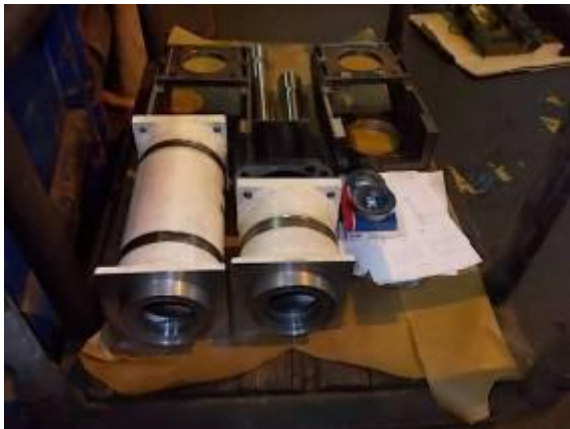
Figure 3) The feed motor was modeled with an extension and a reduction ratio of 1: made. 3

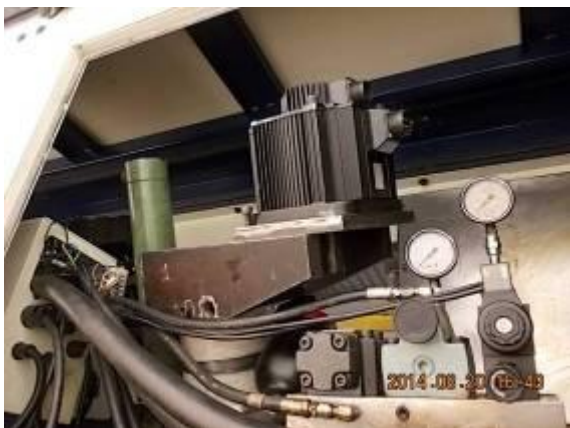
Figure 4) cultivation of the X motor. A very complicated construction, because we have limited space.

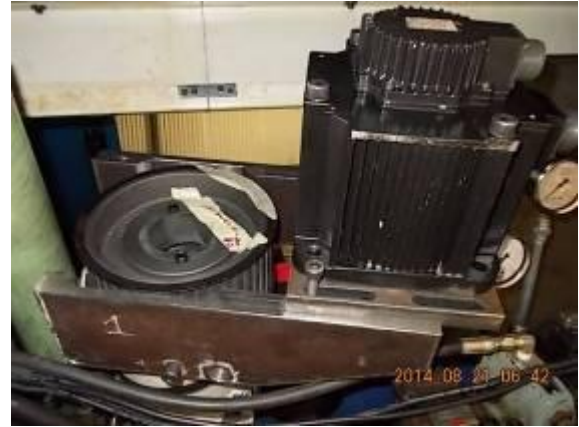
Figure 5) The X motor 1/3 stocky with 3 kW. The old engine had 7 kW and was 1: 1. However, only 10 M Rapid with a 10-er ball screw.

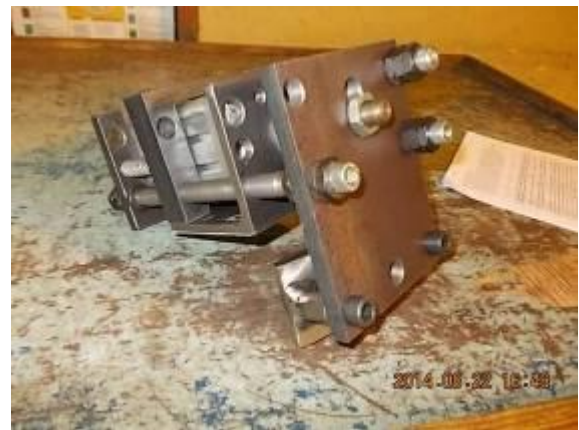
Figure 6) This is the brake construction. This was the old engine in the engine. We now have the same engine on all CNC machines. Therefore, we wanted to order any engine brake.

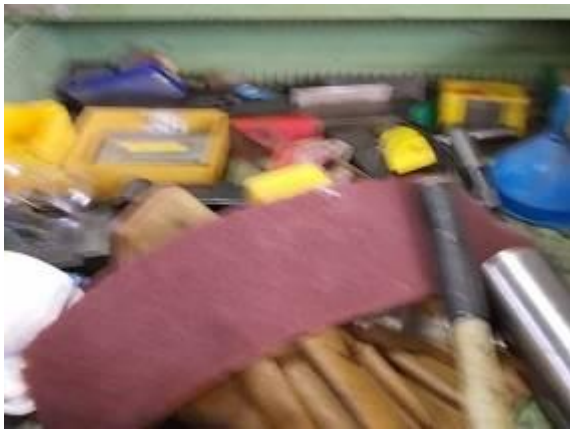
Figure 17) before: In the closets, it looks as if a bomb had hit. Sorry for the bad image quality, pulled the trigger too early.

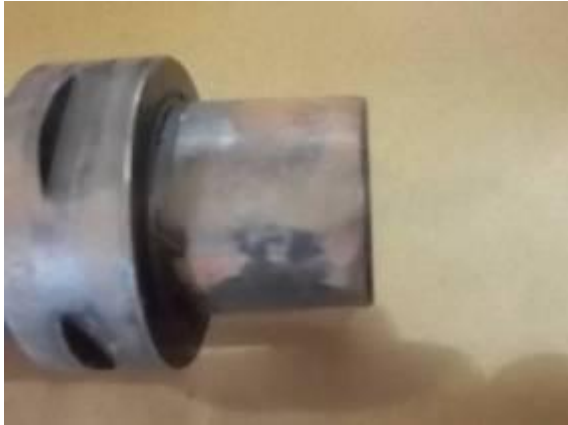
Figure 23) This is a Sandvik Capto tool holder 63. Which costs a few dollars. rusted located outdoors and, No rust protection.

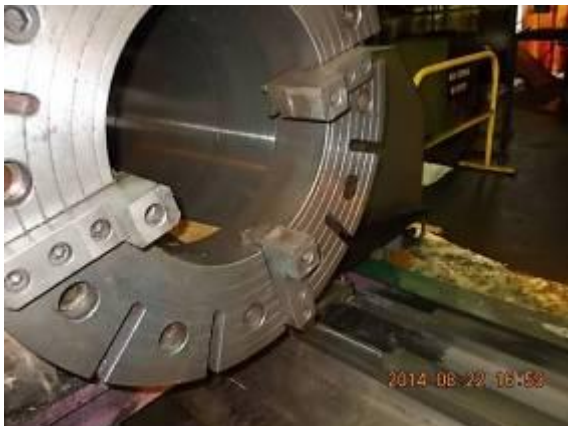
Figure 24) Here, the operators have with the WIAP Gornati these very good jaws of 4 years old faceplate eager to ensure that the threads are broken out so far at the back spindles. Just because they were too lazy to push the upper jaw forward. It is clear that the

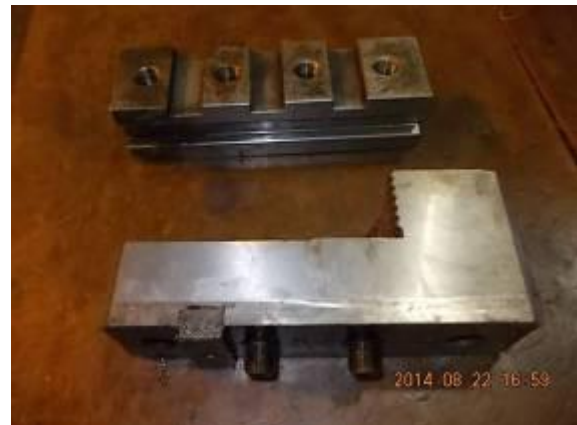
Figure 26) The shoe has dumped because it was too far out.

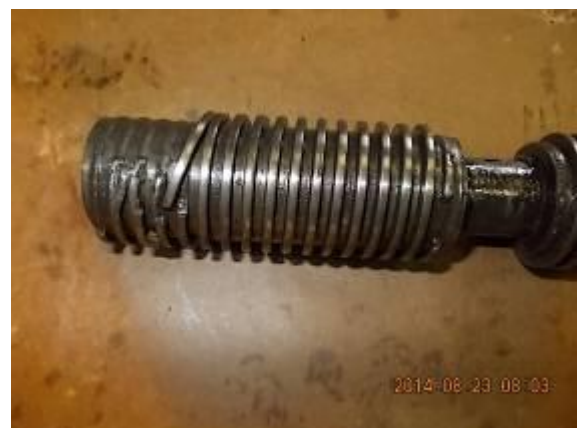
Figure 27) on the spindle pressed off the thread.

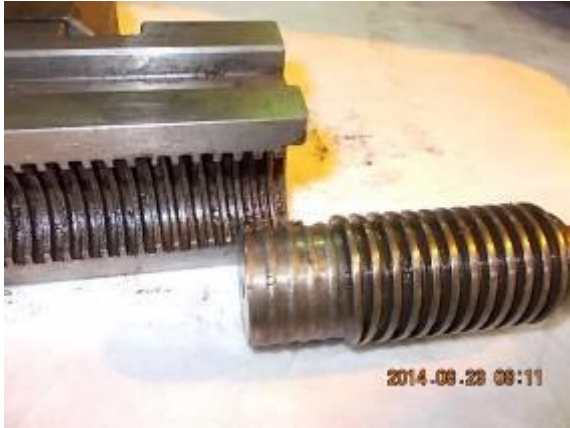
Figure 28) Too far they have unscrewed the top jaw.

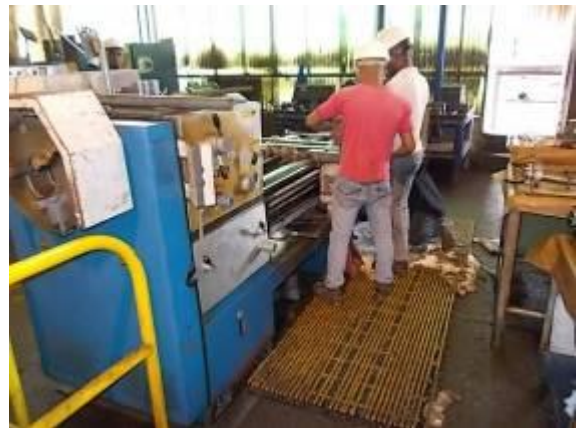
Figure 32) Here we also need to break down the door lathe. The tapping stopped going.

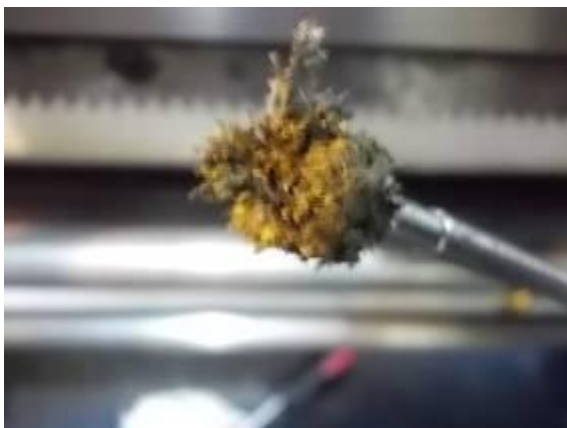
Figure 34) Many such magnets fully chips were in the lock nut. That's why she hung no longer correct and the thread has blended. We then decided to turn the spindle. We have to see if that still can be reordered because the Poles companies have reorganized some. This machine was purchased in 1990, that is immediately after the turn.

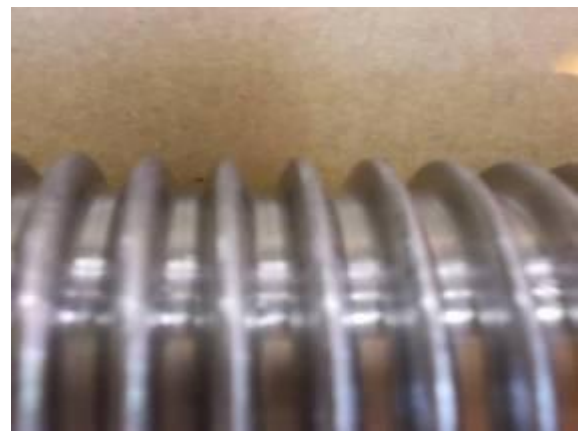
Figure 36) So she looks forward out worn.

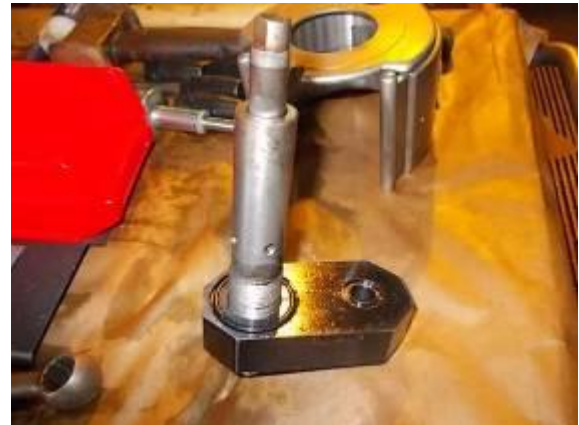
Figure 37) This is the lubricating pump, which no longer smeared. With an eccentric it is driven when driving in the Z-axis at high speed.

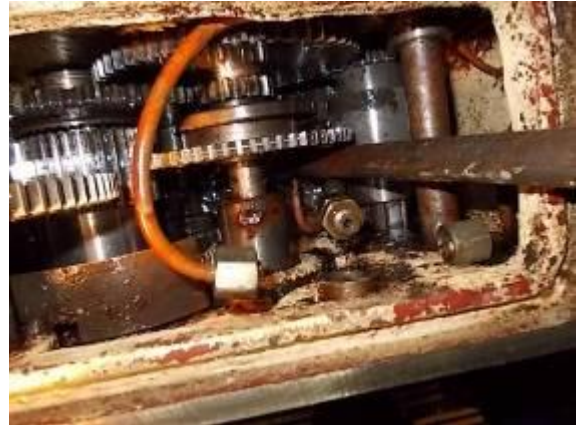
Figure 40) The transmission had a lot of mud and dirt down there. It is impossible to do so to clean without dismantling once each.

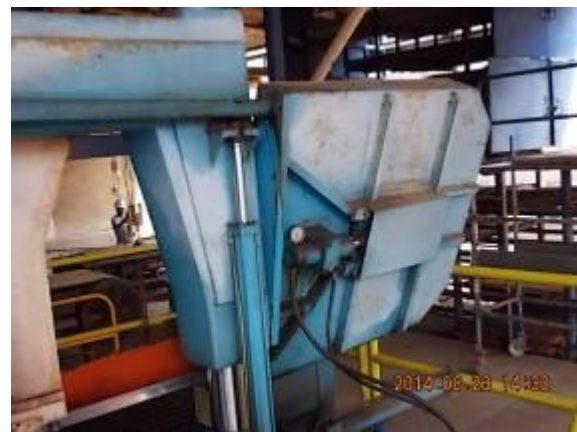
Figure 46) Here, a band saw Knuth from Turkey. It stands about five years here. The color is probably a new, water-soluble paint. It drops. we need new and well paint on occasion this machine.

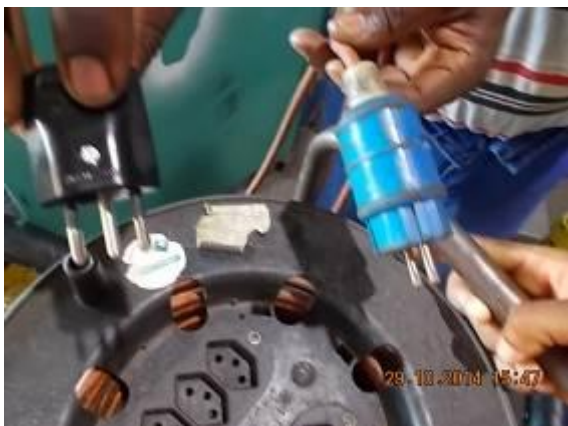
Picture 48a) Many cables roles in Algoa have the Swiss plug. These are designed for 10 amp. Now the plugs are cut off in many new and mounted.

But these are for 16 amp. Now the bushes burn typically in the cable reels.

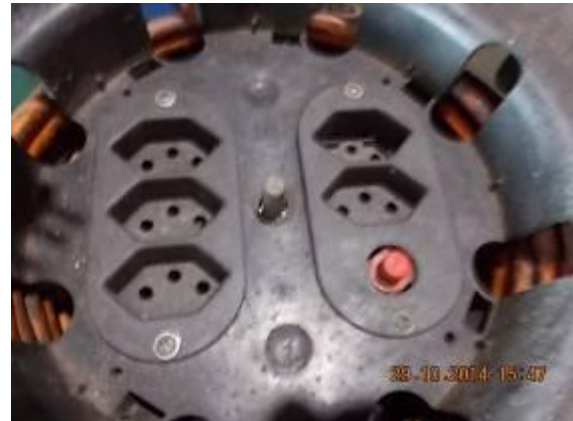
Picture 48b) Swiss cable reels for 10 Amp. Not 16!

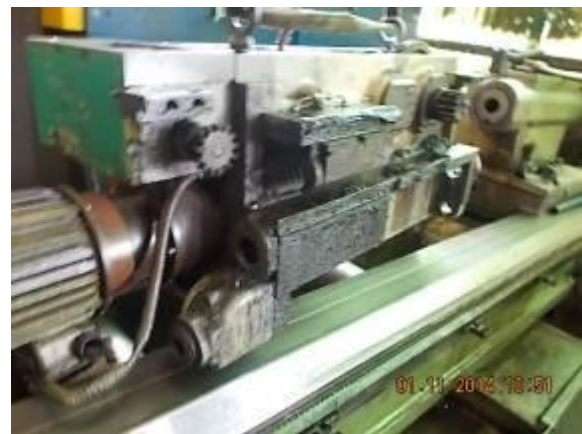
Figure 49) at the Niles lathe has now once demolished 3 a pen. Once pushed off the Axiallagerbock and torn.

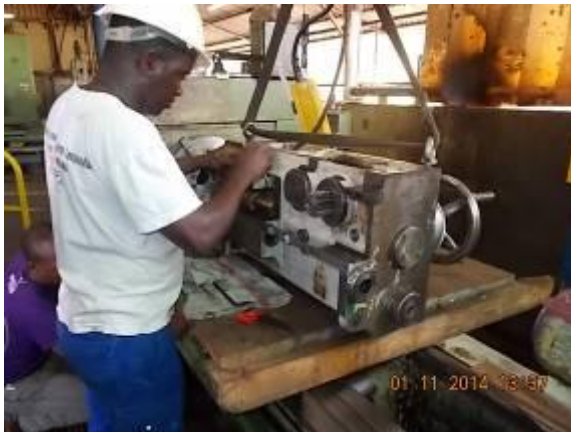
Figure 52) The feed gear from the cross slide was disassembled and made the nip identified. Part of the mother, who is on the lead screw nut is not gone out of the thread out and then has the pinning torn away.

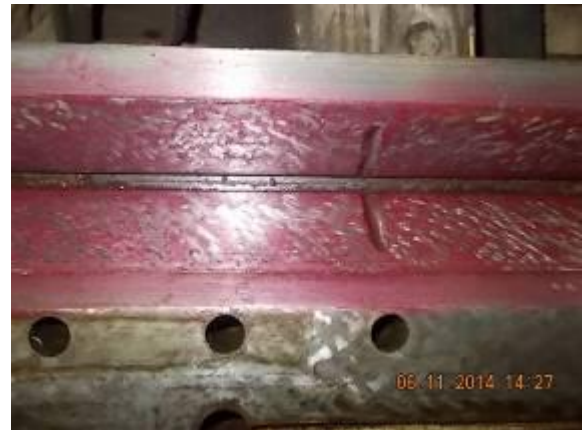
Figure 53) as the carriage was gone, we have seen that the running surfaces of the guides were so strong worn that no more dimples were present. We scraped the carriages treads for even. Since ungeschabte treads to Stik strong tendency slip, which also influences the binding for the Operatuer.

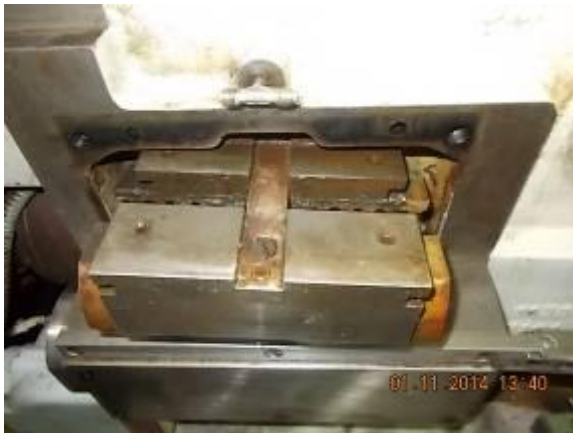
Figure 56) This split nut jammed and did not go into the self. She stopped occasionally hanging in the trapezoidal screw and blocked.

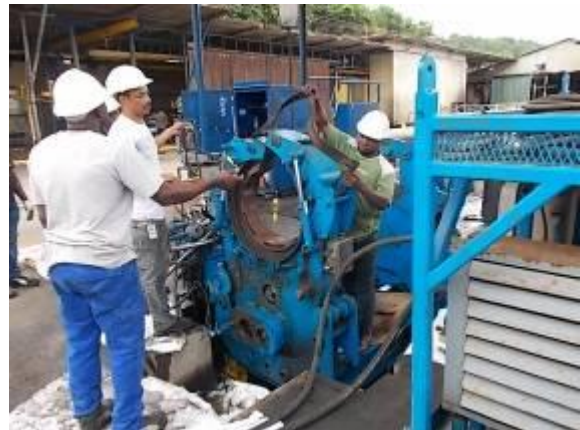
Picture 58b) As it is to maintain, on Saturday, 11.29.2014, at 16:00, came the message that in the Farr machine blocked the transmission.

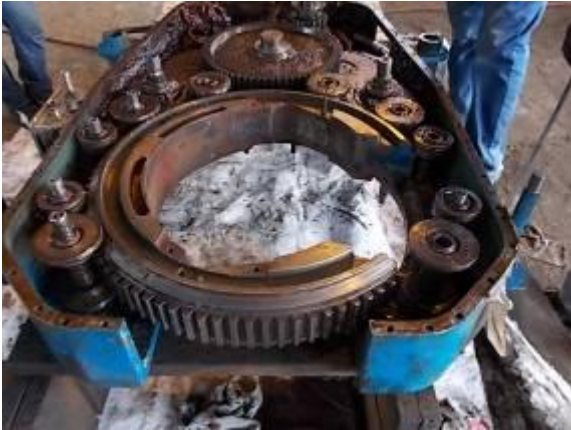
Figure 66) The transmission from the inside looks very dirty.

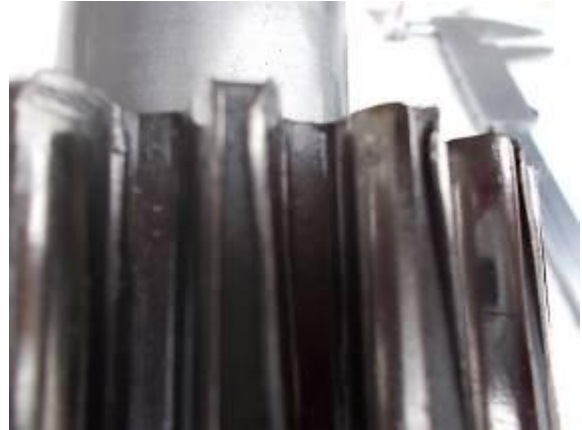
Figure 69) gears where the teeth were weggedrückt.

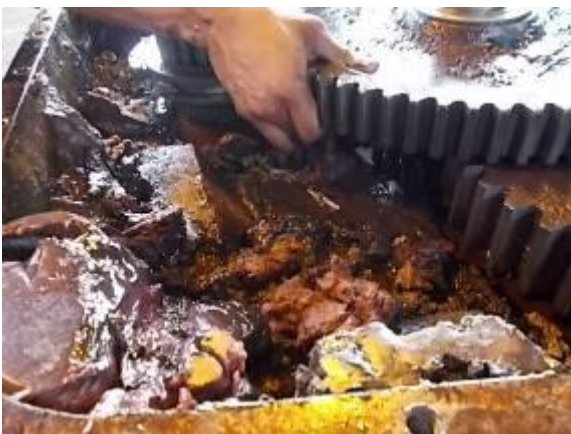
Figure 67) Very much fat, old dirty fat. Also metal objects containing.

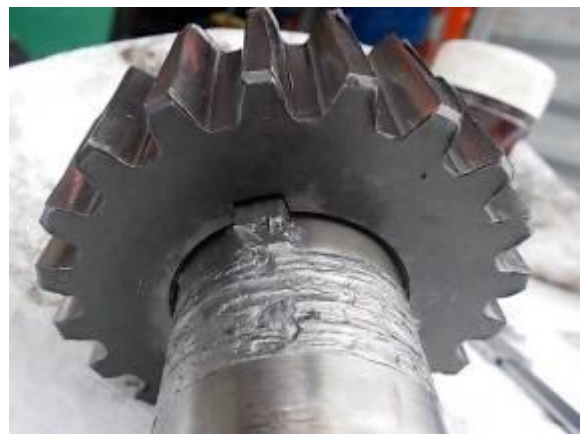
Figure 70) The large gear: The shaft has sheared the wedges.

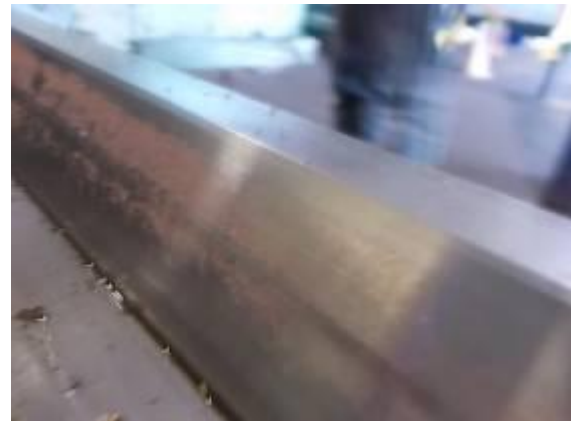
Figure 73) The rust is a big problem in Angola.

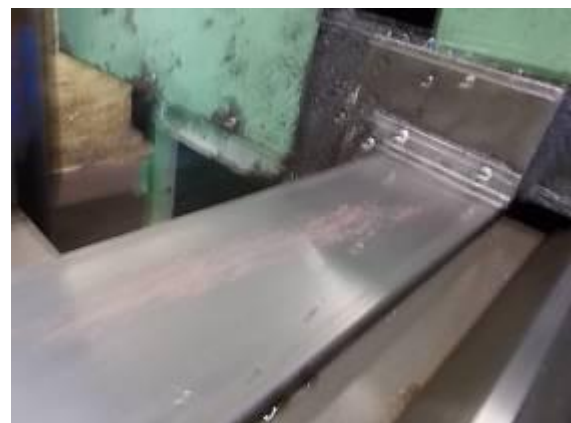
Figure 74) Just days machine downtime and let the rust is there.
