## International staff training in machine construction

### Image report A31: Machine maintenance Angola

Image Report 12.12.2011  
"Hans-Peter Widmer"

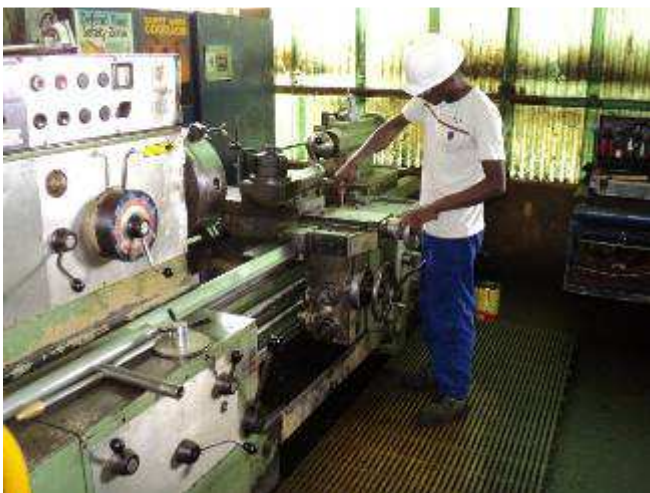
Figure 1: Now you have gone on the service at the Niles lathe. An ex DDR machine. Yoba during prepare.

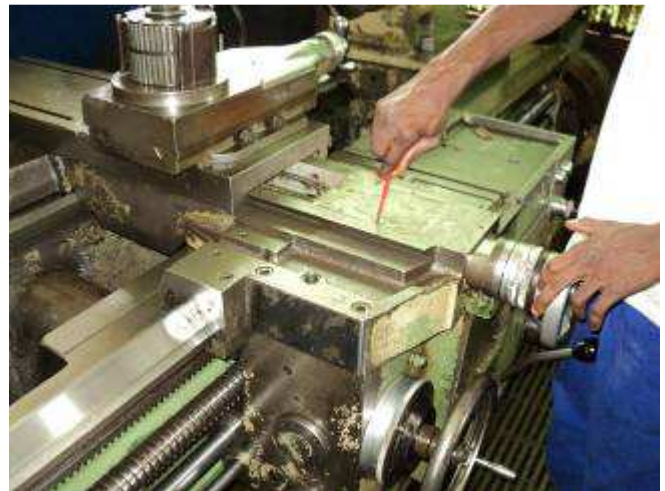
Picture 2: Everything has to go. Among the panels often lies a lot and is only visible when the covers are wegschraubt.

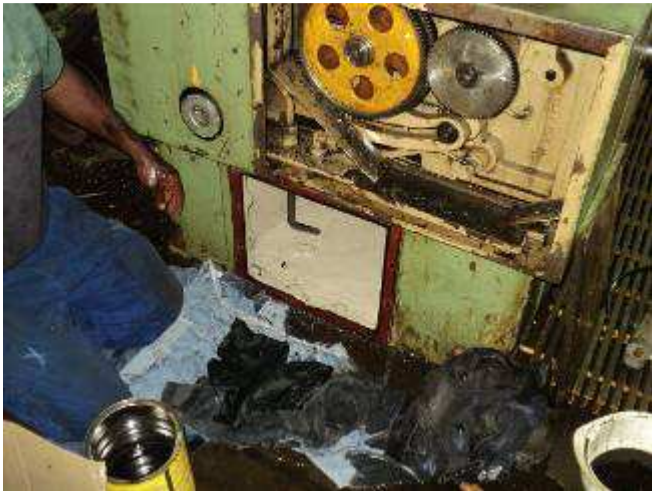
Figure 4: oil change at all next machine. And clean the oil tank inside.

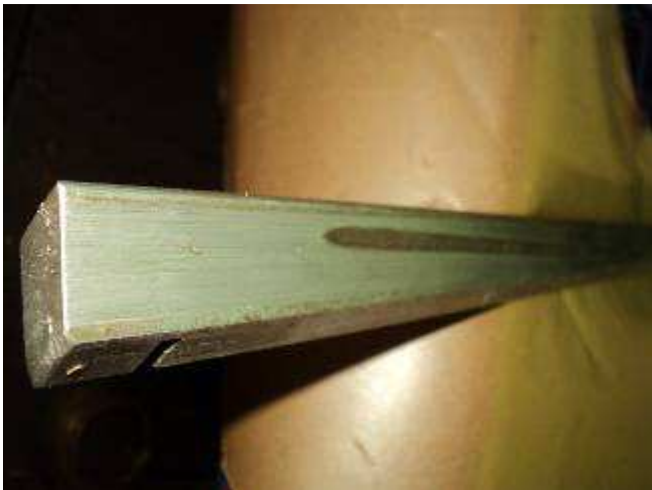
Figure 5: take out wedges and clean everything, ready to scrape at the next service.

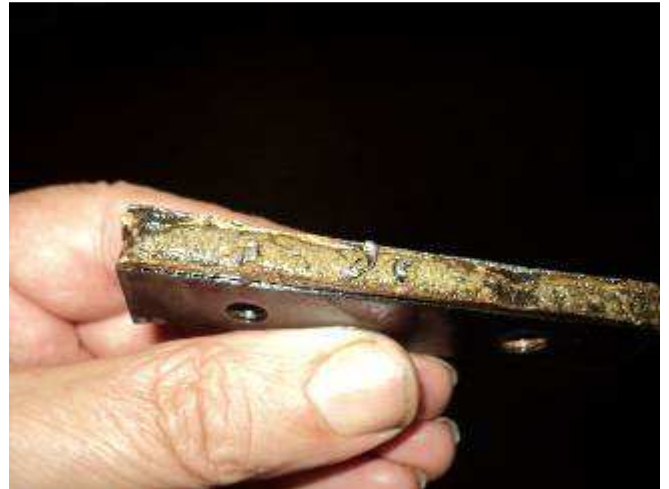
Figure 6: The stripping see no longer so fresh. New rubber we have in stock.

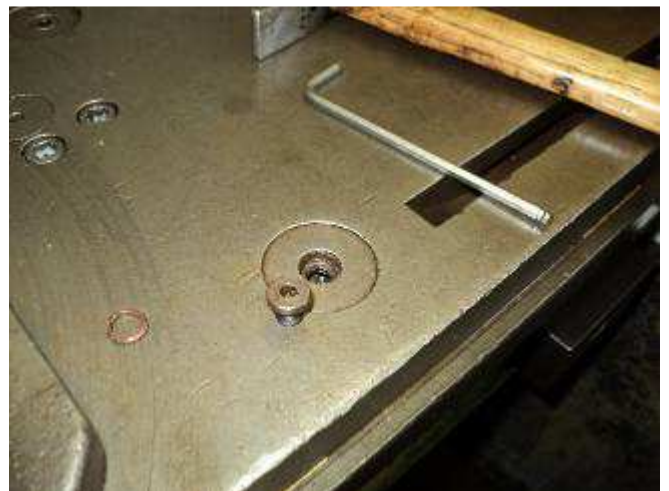
Figure 7: The fact that lubricating points are under the screw from the X slide, is marked in the future with a red color.

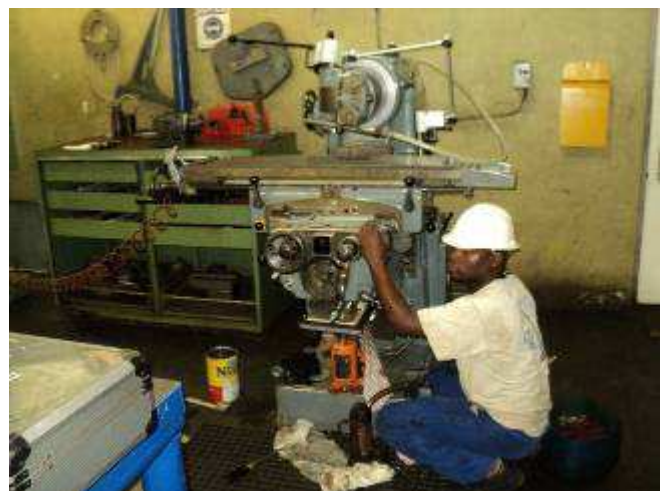
Figure 8. After Niles lathe comes the Schäublin milling machine turn. There is a clear-year plan, when, what equipment needs to be serviced. All machines are serviced.

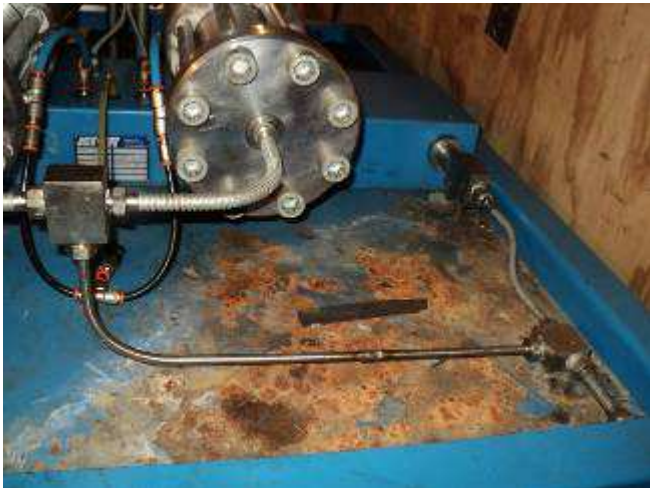
Figure 10: At the Jet Cut water jet machine has been reported at a standstill again in the last days.

It always came the alarm vacuum and that is too little water or too little air as if it were there. But that was always plentiful. So other causes are sought. One was that the contacts are burnt off at 2 relays that move the Kolbe the cylinder back and forth because the thousands of times off strong sparks. We changed the relays and continued to work and watch.

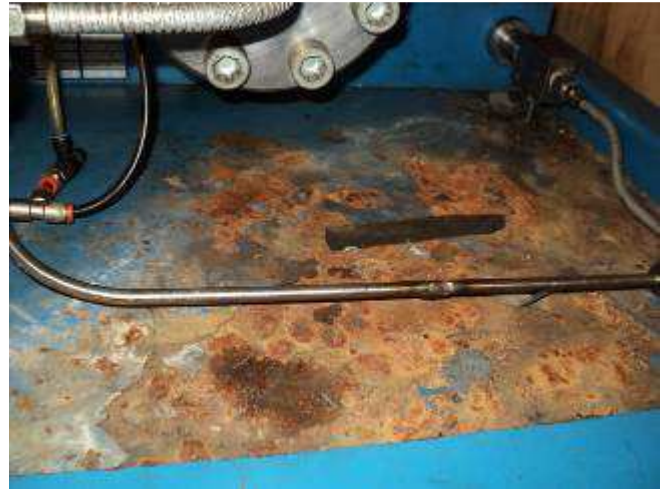
Figure 11: This is also a defective pipe was welded. Through these tubes but goes beyond 3000 bar pressure, so we have organized new pipes from Switzerland, so that they can be replaced. Is not without danger.

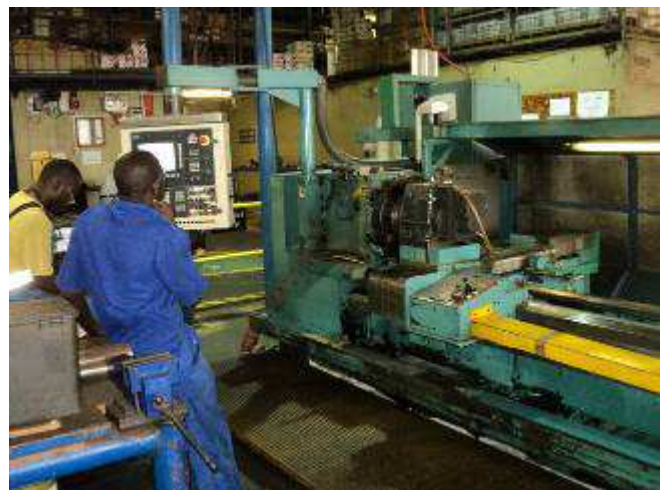
Figure 12: Now is the CNC lathe Weisser turn. It is taken out of production.

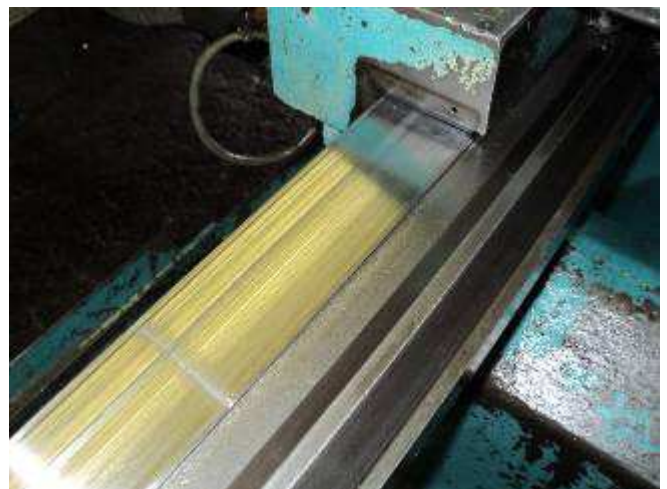
Figure 13: The rear Z leadership has for some time ever lower tracks. We planned to lift the Z slide and examine the cause again.

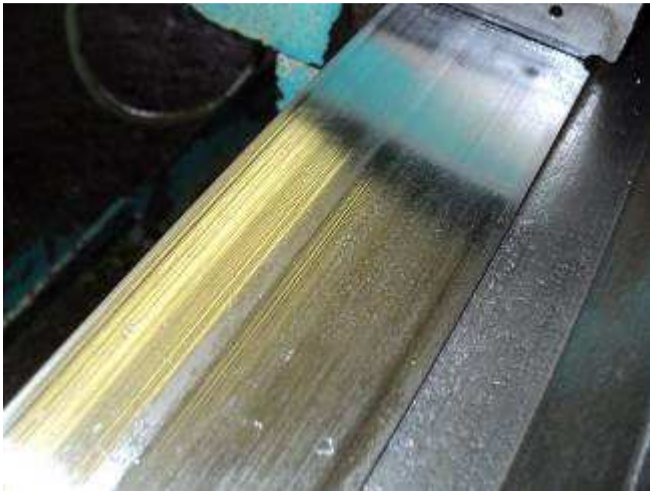
Figure 14: It has running tracks. However, since this affects in contrast to a slant bed machine, only the top level, it has no major impact on the accuracy.

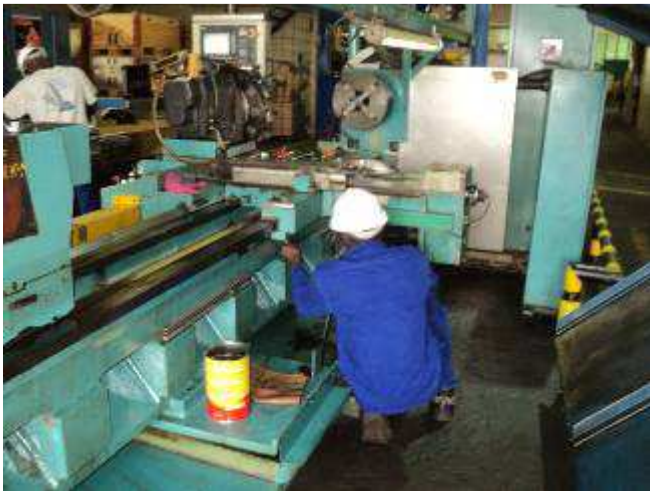
Figure 15: It is prepared everything to lift the sled. Under handles away. Ballscrew away etc

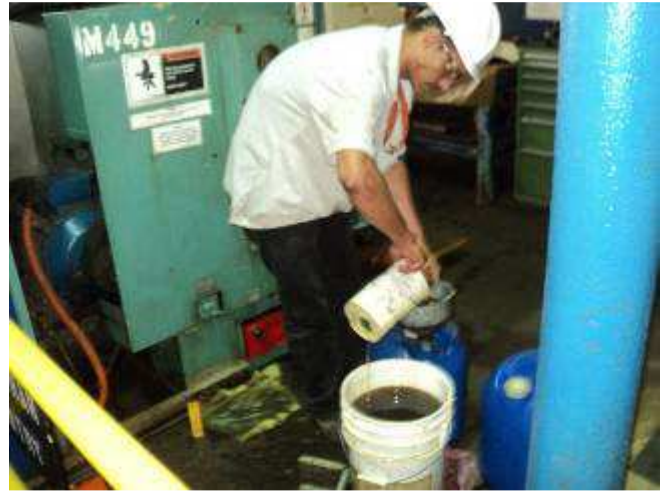
16: But the oil is replaced. The tank is cleaned inside. Often there are problems with the "bosses" of the "Machining" department to get the equipment for maintenance. Recently we had to them, say how many times: whether they know why almost no planes fall down today? Only because of the preventive maintenance. It was then said that one purpose is to force that they can release the machines!

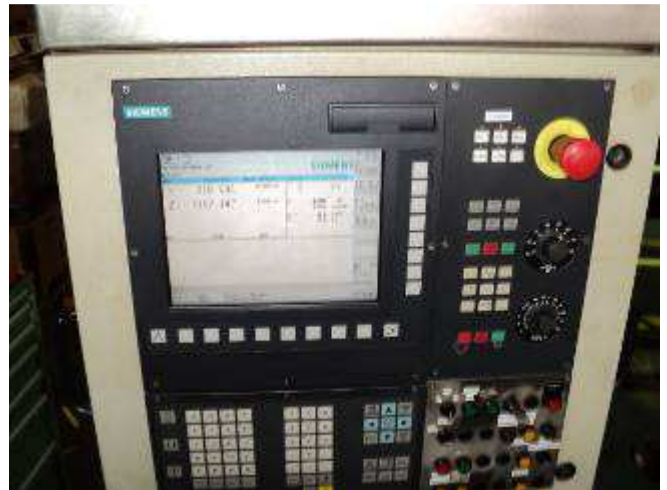
Figure 17: This is the CNC control, we grew in the year of 2006. The previous Sinumerik 810T is long gone in use.

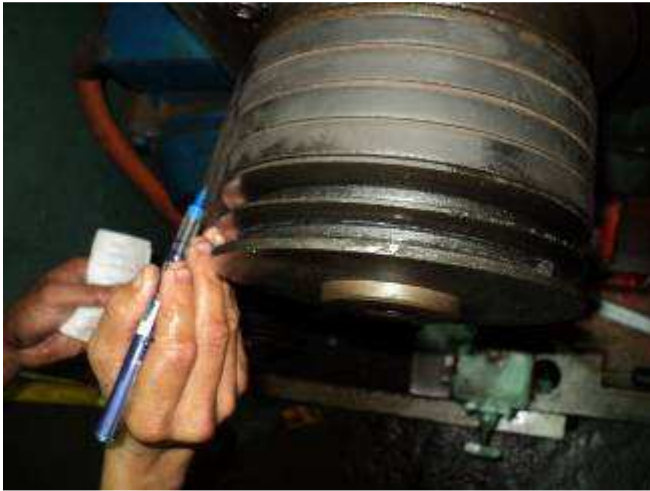
Bild18: The V-belt of the spindle motor also look not good. We have now expanded our maintenance list so all machines covers all belt with storage location that is bearing number. What is missing is ordered. The yes only cost a few dollars. But if it's not here, it costs a lot when you have to let it send by DHL. Our young people will keep but now encouraged so that they have at least once from all major machines, a set of belts in stock.

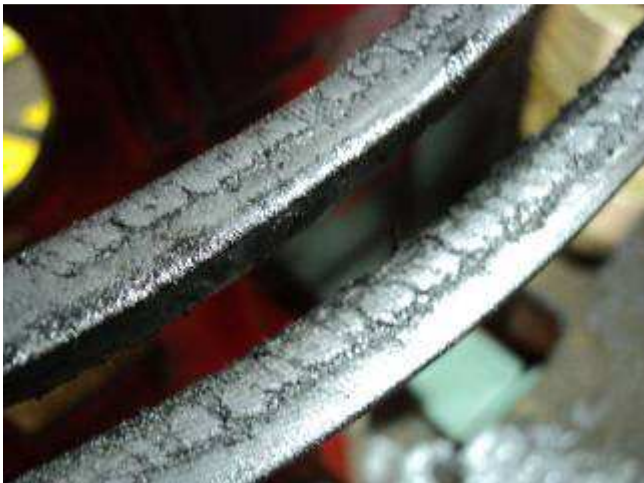
19: Yes, these V-belts must be replaced, but are not in stock.

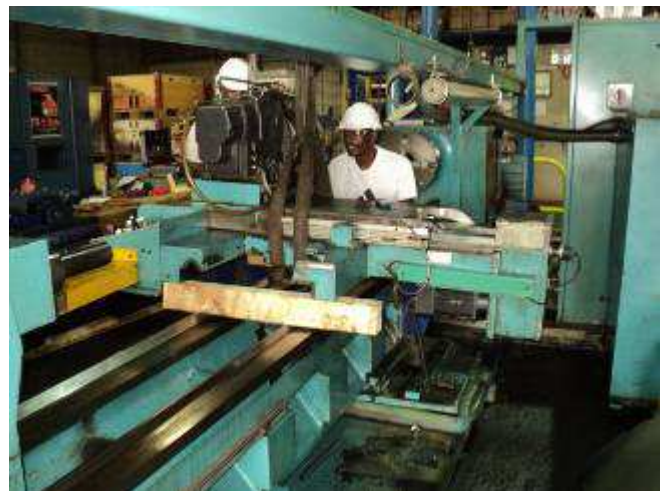
21: Now the carriage sits on timber and is ready to examine why the guides have these running tracks.

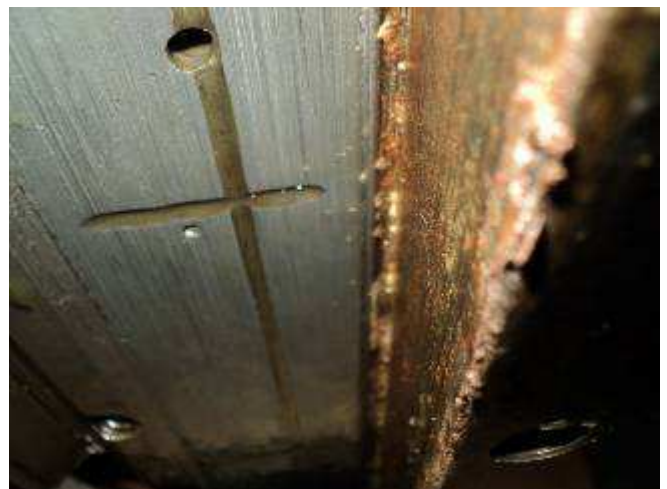
Figure 22 The lubrication was not ok. There have been no oil feed holes by the machine manufacturer from above. We made two new lubrication holes and installed two new oil pipelines and installed two new dossier units.

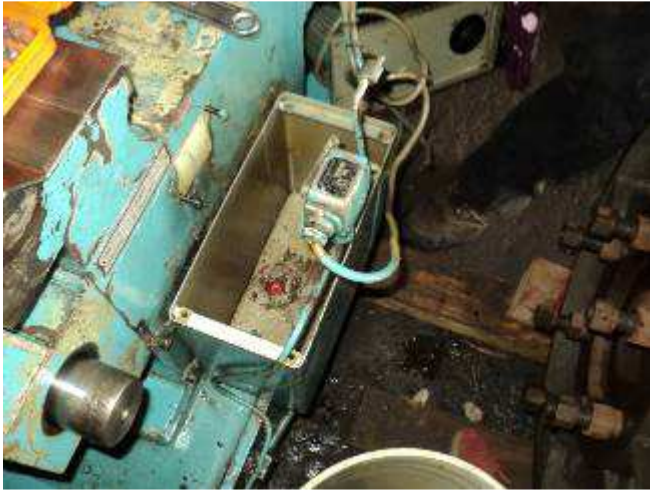
Figure 23. But the bed track lubrication container was cleaned inside. It was like many times before, a lot of dirt in the tank.

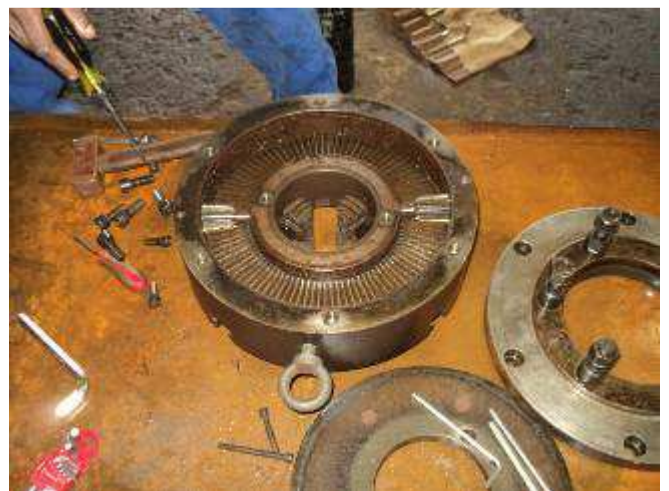
Figure 27: The food must also be dismantled. It looks questionable, although it breaks it down again and again.

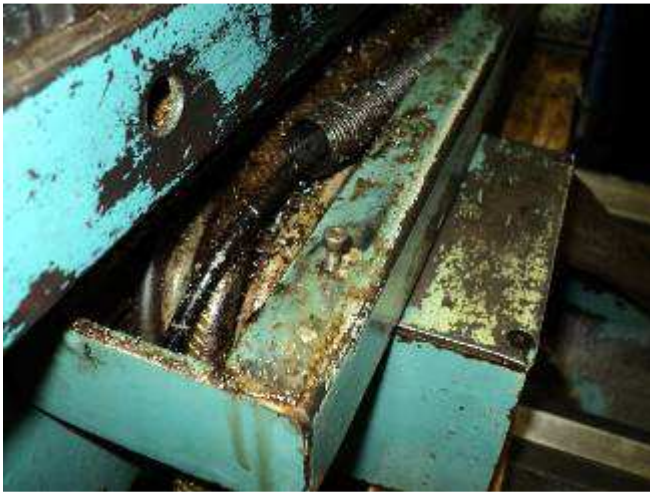
Figure 28. When a trailing cable cover is opened, it looks like this. Dirty and waiting for maintenance.

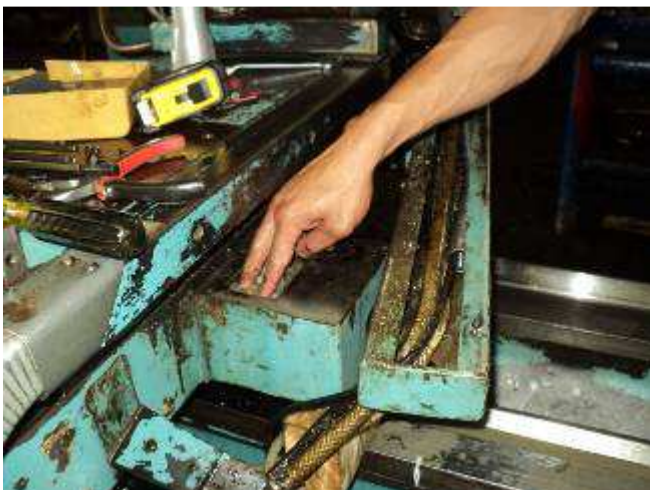
Figure 29: This was the old Oelstelle from the old conventional system. Safe 2 liters of oil was in it and smeared the old time itself. But with the construction of a CNC machine these old grease variants were no longer used. It was attached to the central lubrication system. This are now these old oil container full of old emulsion.

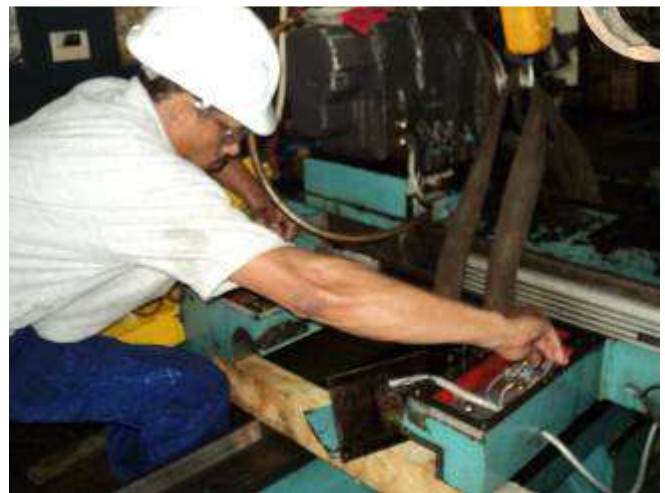
Figure 31: Carlo installed the new lubrication lines

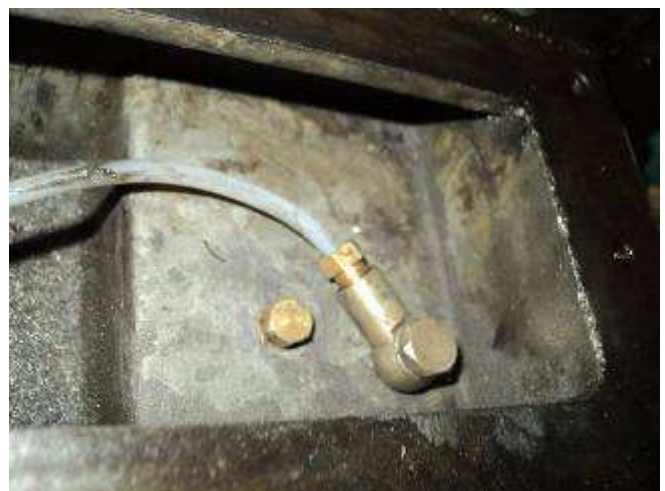
Figure 32: There were drilled new holes which supply the guides with oil.

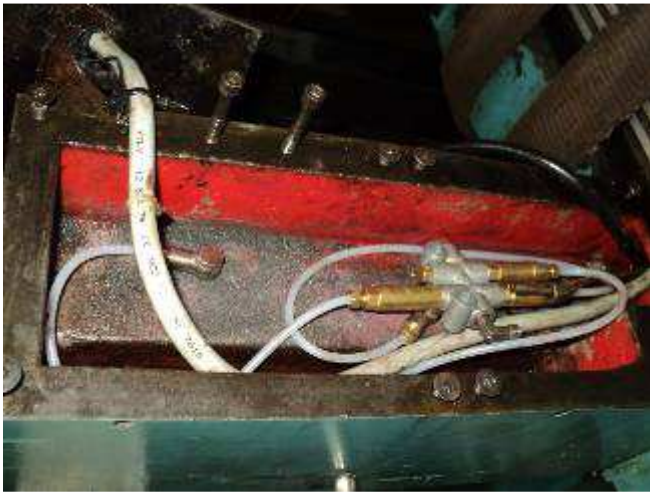
Figure 33: The new Oelverteiler with 2 Dossier units. 2 pieces of type 16 lubricating points, and even a type 10 it.

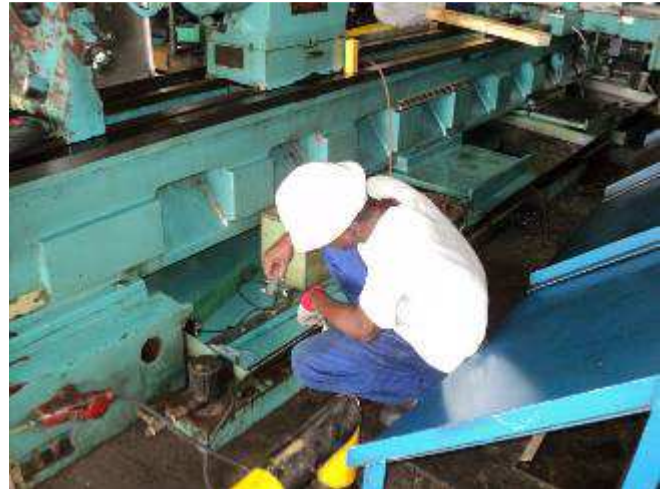
Picture 35. Here Yoba has seen some new O rings must be mounted. Measure Yoba while.

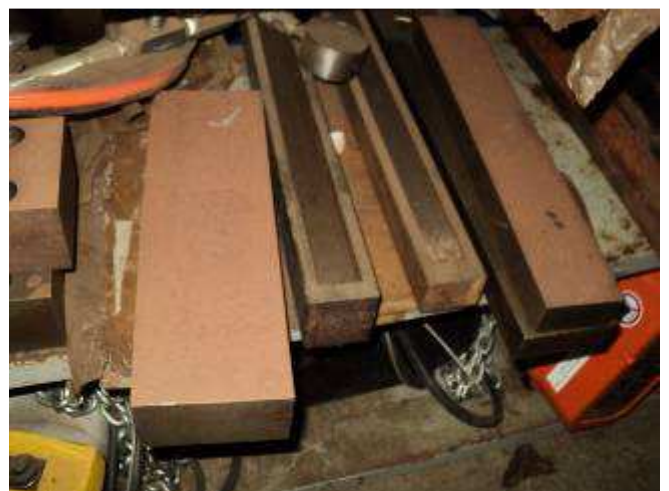
36: Then we looked in the tool room, if we can find a ruler to Rescraping the guides.

What you see there, hurts. So much rust. our maintenance people are now getting all months to send me a picture, so that something does not happen the job.

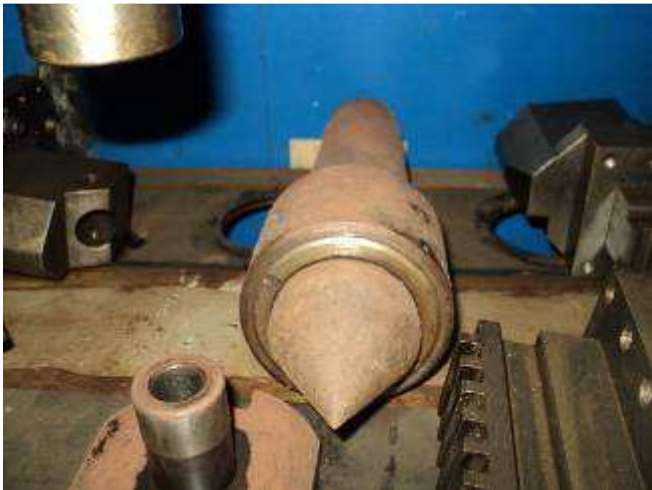
Figure 37: All rust, just because you pocketing no oil fat blend! This need not be. Our maintenance people are encouraged to always check this and make the "Store" attention.

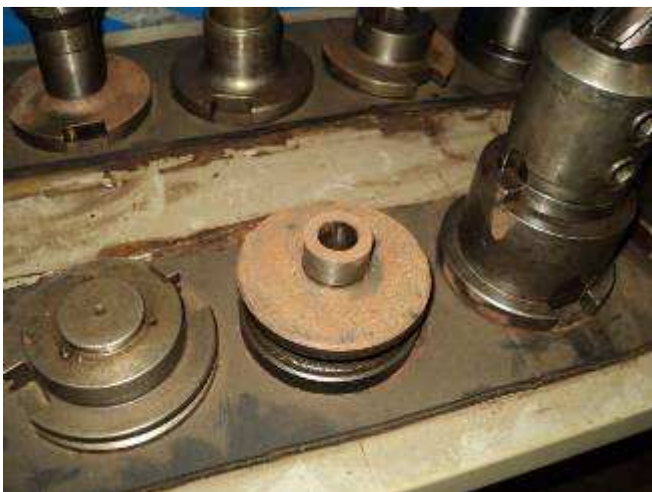
Picture 38. It is only the rusty, which has seen no oil or grease!

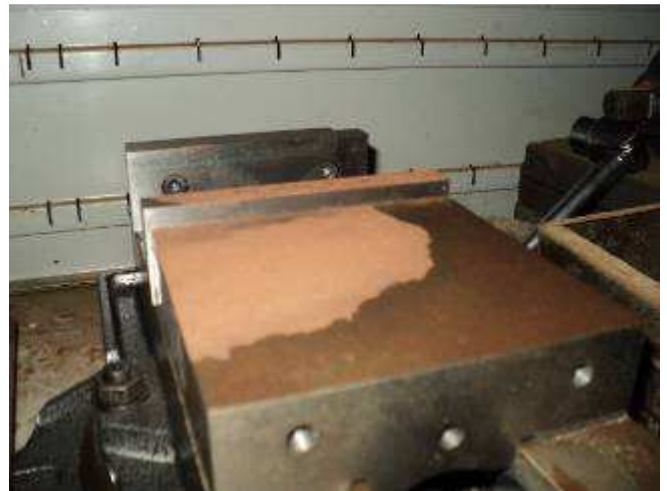
Picture 39. Why do so rusted a beautiful vice? Since we will have a serious talk with the camp people. That's a lot of money that is damaged here.
