# Photo report wi\_8\_f\_2500\_Tripp 2

## 2015 Angola HPW

Photo Report 07:06. / 06.23.2015 "Hans-Peter Widmer"

### 1. Mega Bore CNC lathe

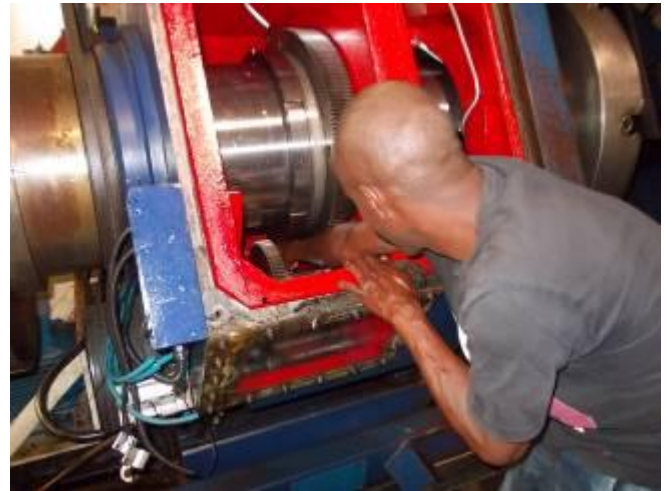
P9: Below, under the oil, is a flow filter. Only accessible with a very long arm.

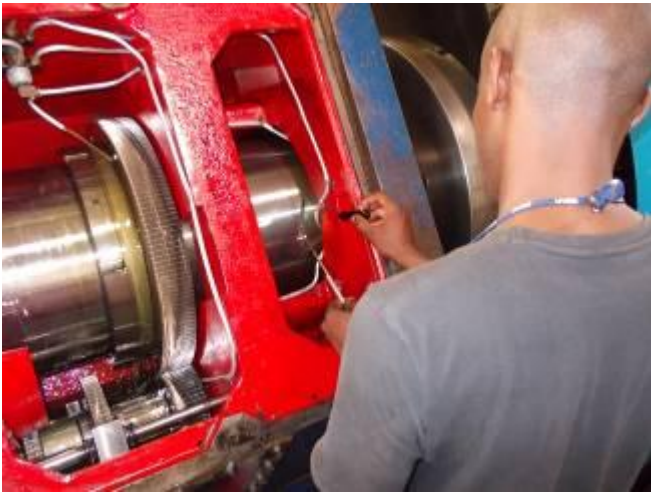
P12: Now the gear again looks nice. The filter system has to be also grown.

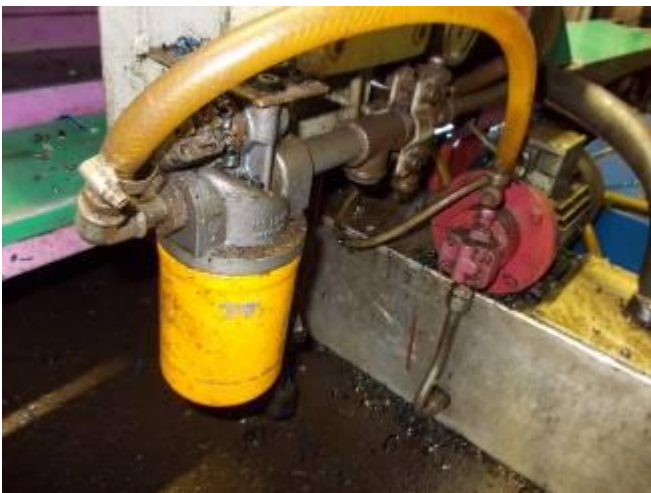
P13: At the Gornati: With all CNC machines of the WIAP, it has 10 micron filter. Outside with a signal switch, so that the dirt in the oil can be intercepted. Each gear of the machine with the filters, can after 10 years of gearbox cover be lifted. It does not have any traces of dirt.

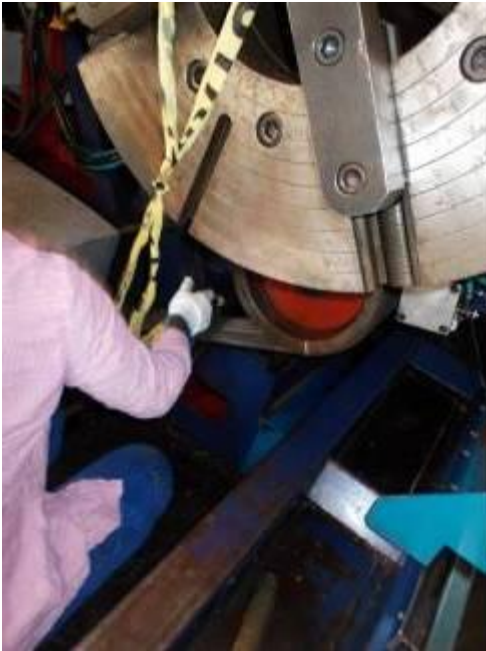
P16: The headstock was 300 mm 0:17 mm diagonally. Very complex align the headstock at a slant bed lathe.

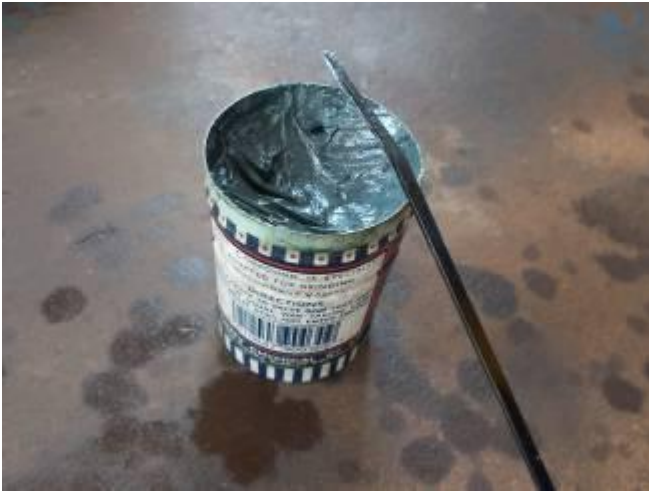
P30: With lapping paste the clamping slide has yet been made accessible. This has to be cleaned very well again. Not the residue then lapping.

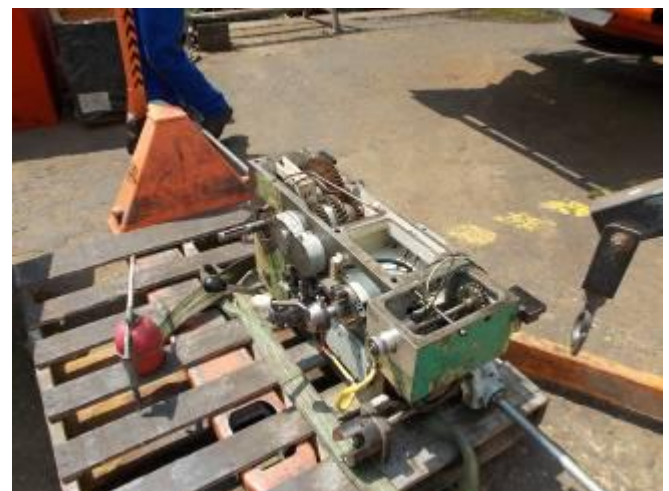
P32: The pressure controller was in the purification. It was then a slide in the hydraulic block jammed.

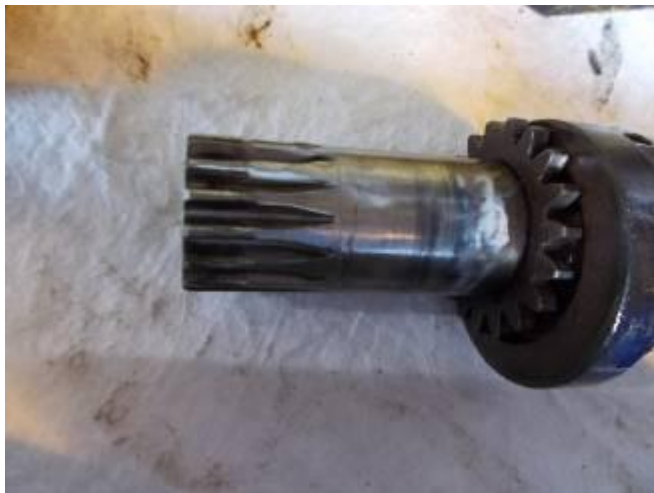
P36: The defective wheel in the feed gear

P37: The defective wheel, the smaller, the more teeth are broken. Was welded and repaired. Unfortunately not good enough. The old module was chosen wrong because the break anything so deformed that it could not be determined correctly. When the gear was worn with the dividing head, teeth were once with too little, then again with too great a distance.

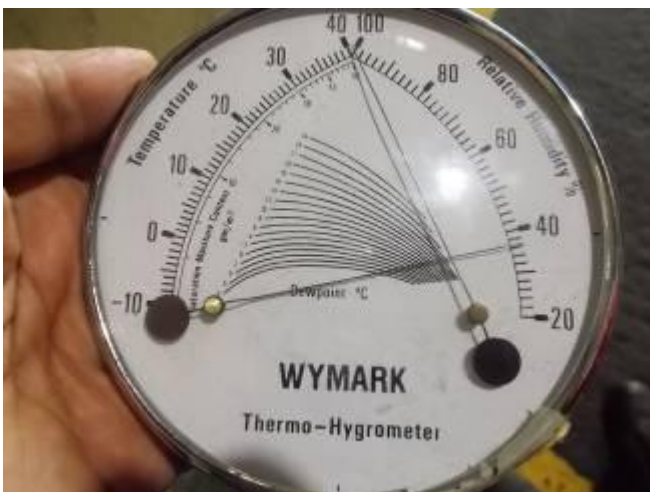
P43: For the Weisser CNC lathe we needed the thermometer, which we had forgotten in the closet of Gurutzpe. Just 40 degrees Chill and humidity below 40%. All right. Ev. Aircon still install and cool to 32 degrees down. Not deep, otherwise there is condensation.

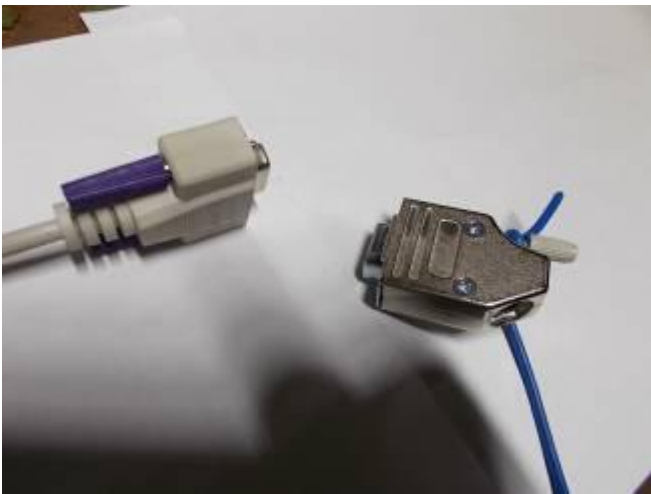
P48: Inlet Protection. But tie everything in Angola, which is quickly gone.

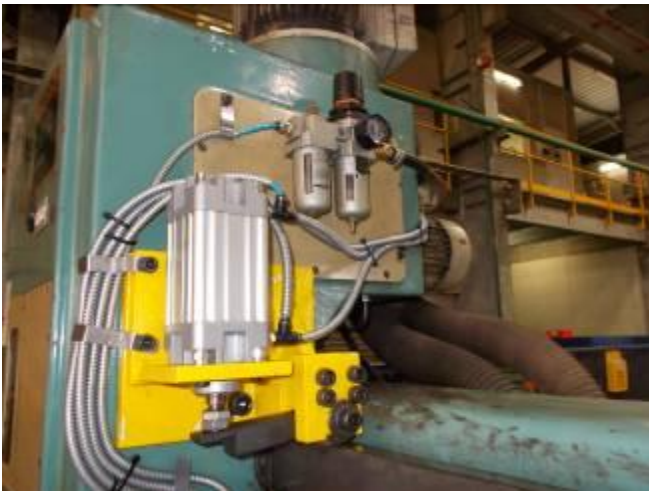
X54: The lines were protected against chips. Such protection hose, we also need to take in the order list. We still had a few feet in the camp.

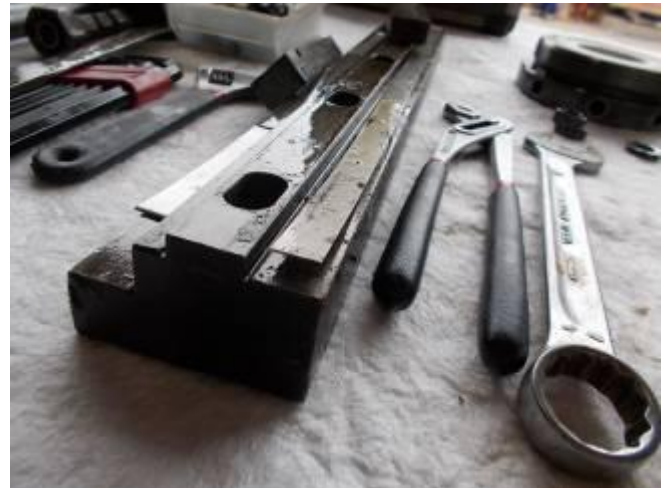
P61: The company has instead milled and scraped, backed only board lessons as distance. Unusual for a mechanical engineer. Normal is milling and scraping usual.

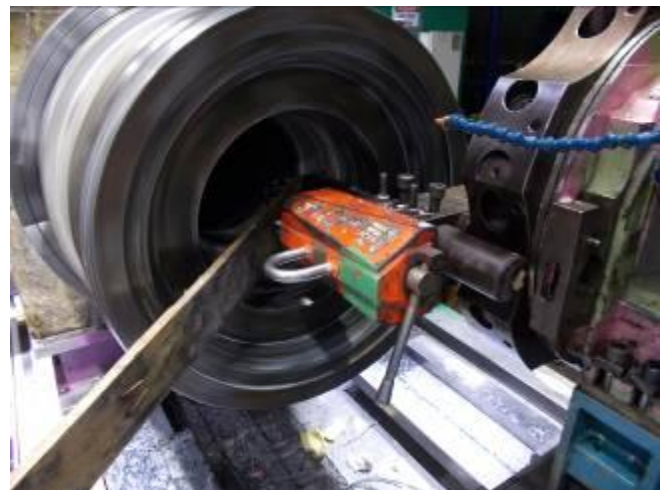
P: Unfortunately, too few steels are available in order to turn vibration free can. It had to improvise something.

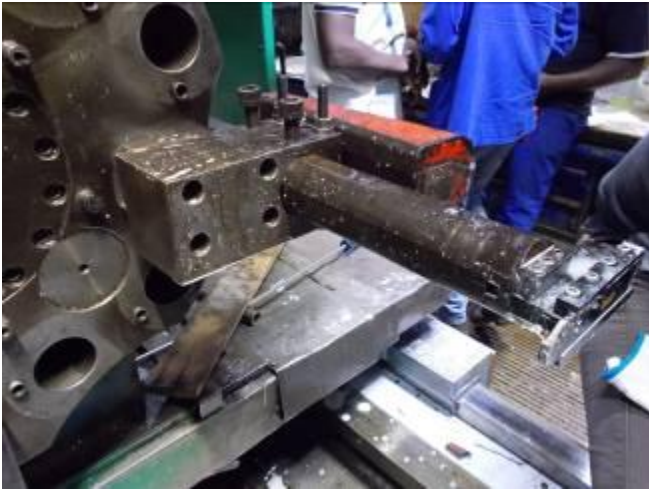
P70: to make a Innedrehstuhl of an outer turning tool, was complicated because the geometry had to be adapted. In other words, an outer steel has a different clearance angle than an inner steel.

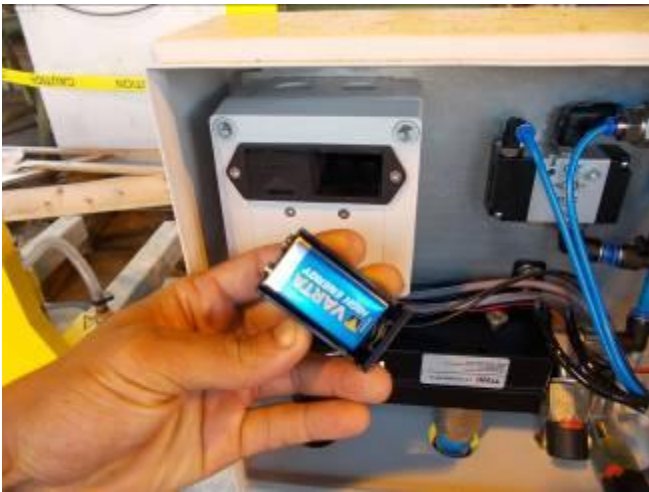
P63: A battery unterstütztes system. 2 batteries

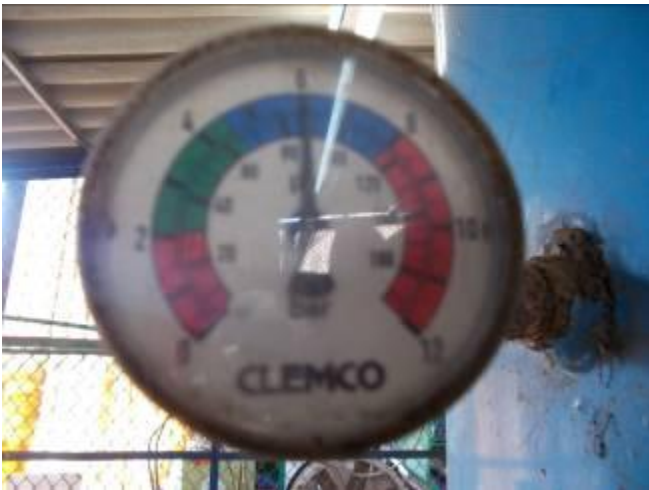
P64: Before starting a test system, if the system pressure corresponds to the pressure.

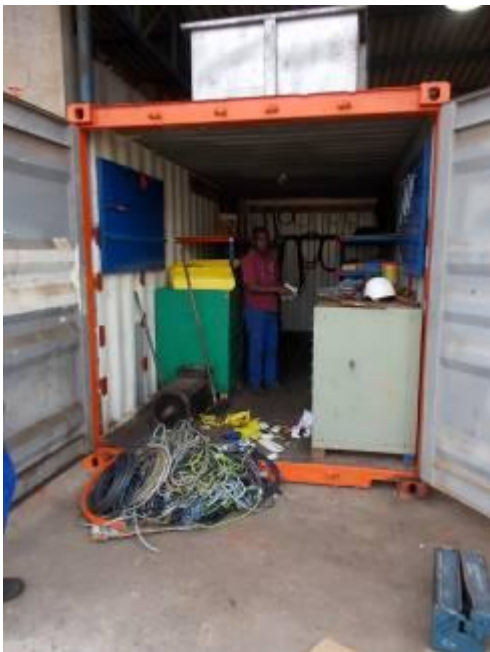
P67: Alberto has been around for 2 years to clean up the program container. He now thought possibly it's better he does it before I come up with the idea, because once again to look in!

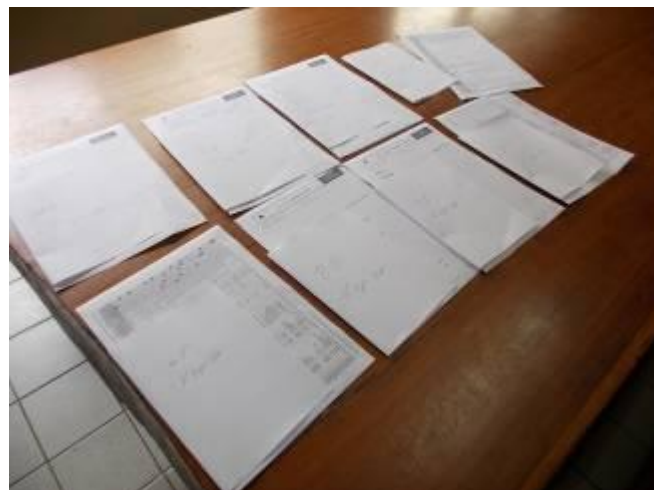
P70: Always the end of June each year, all the documents of the machine to be replaced. Renewed. The old stored in a folder for the auditors who always come and ask for it.
