Picture report. Angola Trip1 - 4, 2014. report Summary

Conversion CNC lathe Mega Bore

Title: WIAP maintenance program
MEMV of everyday life report

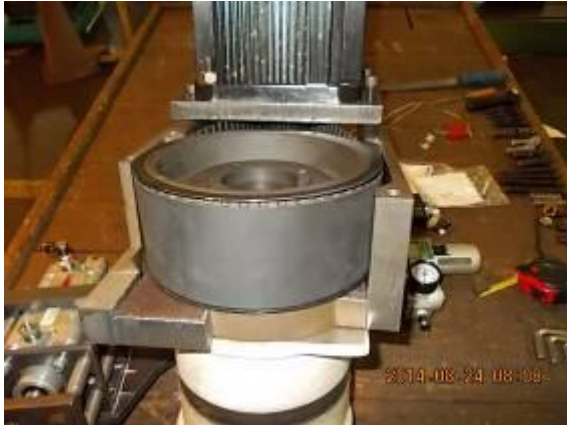
Figure 7) on the motor extension we made the motor with a rotary flange. So that we can turn the engine in any surrounding location.

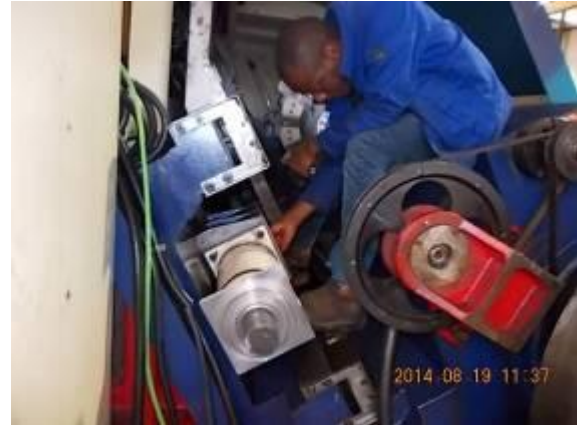
Figure 10) Yoba during assembly of the Z-motor extension.

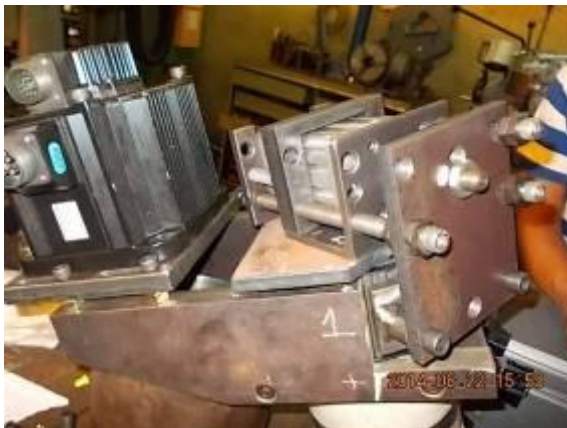
Figure 8) This is now the belt brake with the 63-cylinder. He presses with 6 bar, 164 kg.

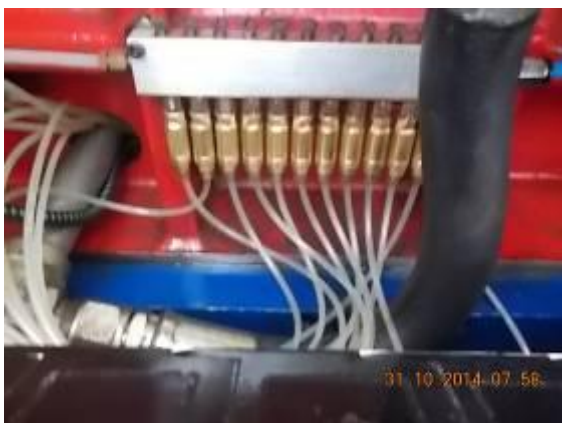
could not be recognized a lubricating interruption.

Figure 13) The old, existing lubrication system has no pressure control, thus

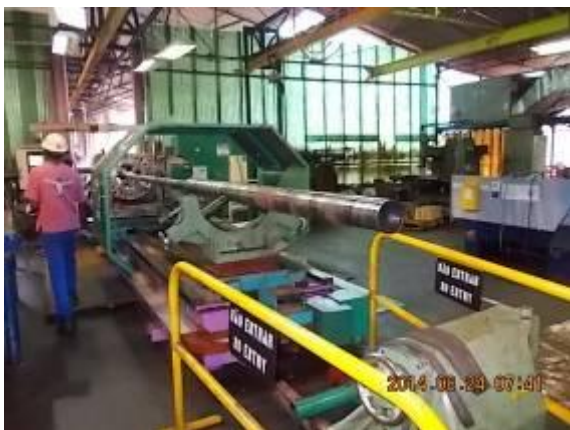
Figure 30) The machine can now go on these thin shafts again.

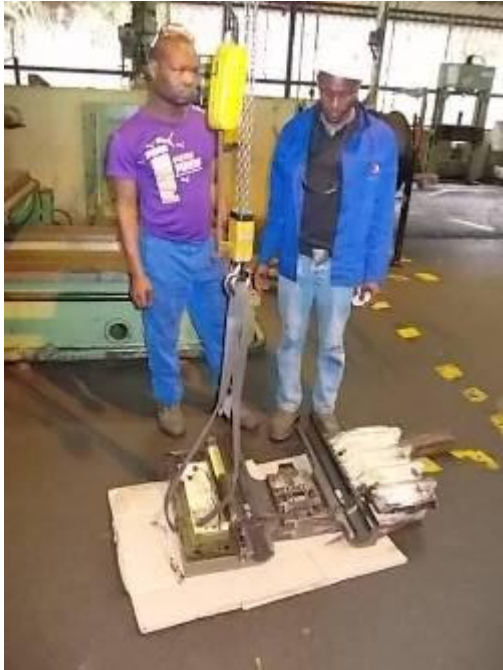
Figure 38) and Antonio Yoba recover after removal of the longitudinal slide.

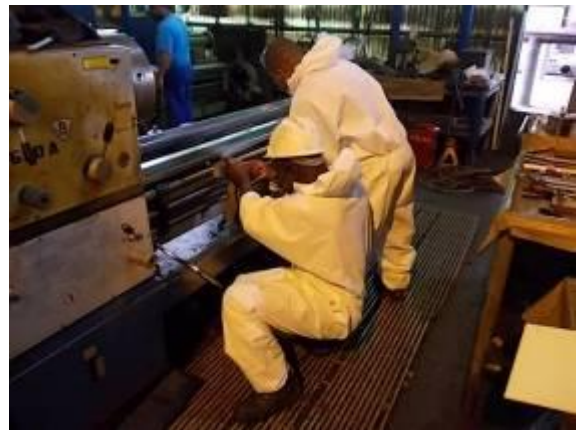
Figure 41) UVEC protective suits are required in Angola. Without this must not be cleaned with diesel.

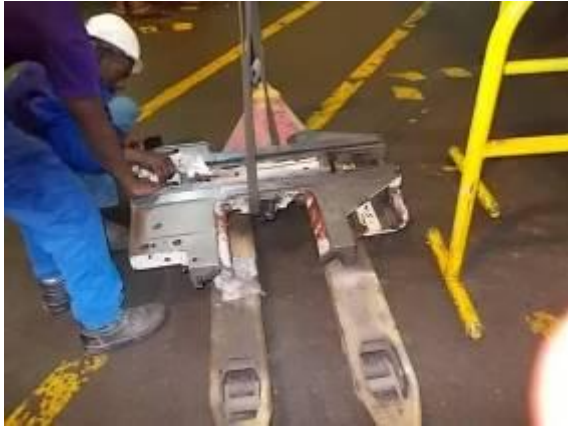
Figure 43) The cross-slide is prepared again for the assembly after a thorough cleaning.

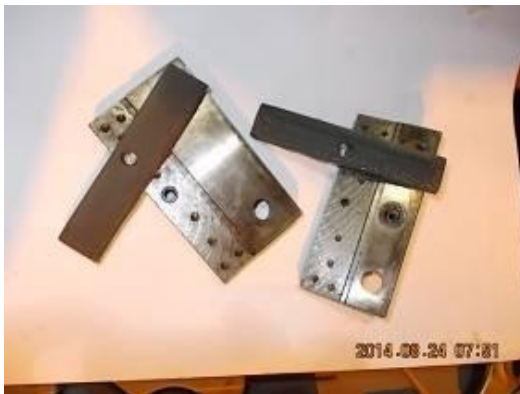
Figure 44) Again, due to the V guide, the lower handle that is not so old machine TUR is so loaded that it has the sliding coatings, demolished by the transverse forces and then press the intense upward. We had to re-roughen the bonding surface so that it has cavities for the adhesive. Then re-bonding.
with brass for countersunk screws against the re-tearing of the sliding coatings.

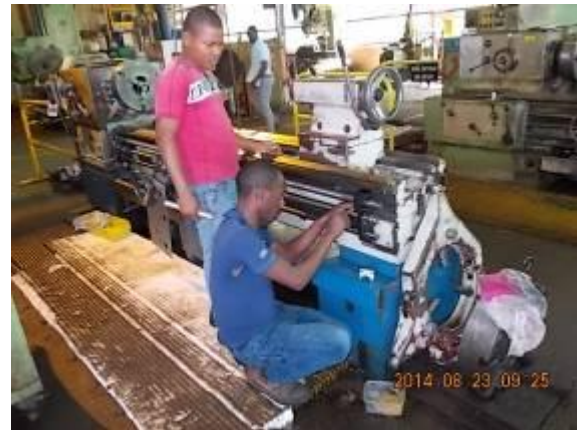
Figure 45) The re-assembly in the process. Yoba and Bambi. Kevin brings new belt and a new thrust from Switzerland.

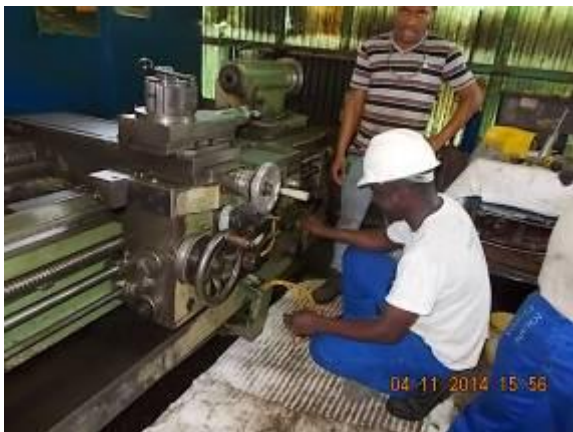
Figure 57) After approximately 4 working days of the carriages was refitted.

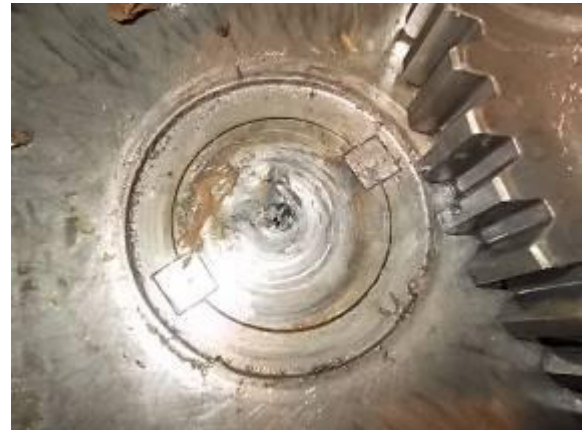
Figure 63) Some damaged areas.

Figure 60) a friction weld in the transmission

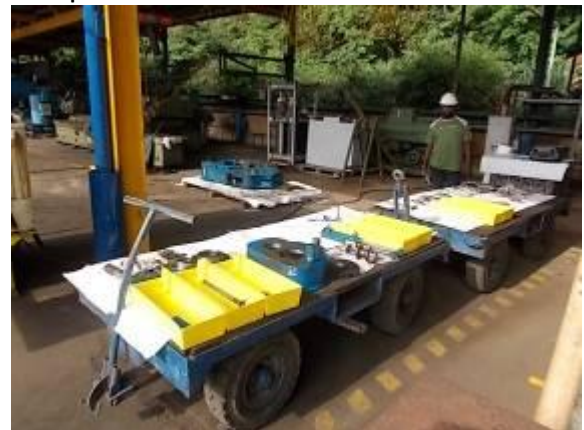
Figure 61) The inner member is removed to disassemble.
