## Image report A32: Machine maintenance Angola

Picture report 12.12.2011 Hans-Peter Widmer

Title: Preventive machine tool maintenance, top people trained by WIAP

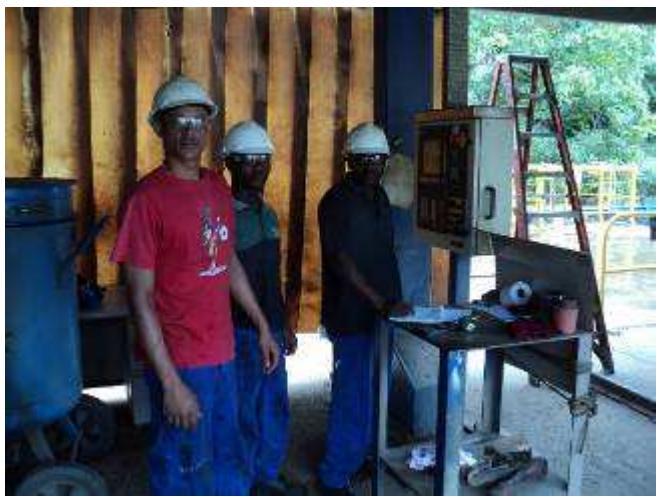
Figure 1: Carlos left, center Yoba, behind Toni, the water jet machine operator. It searches a mistake. From time to time, the machine and goes to vacuum.

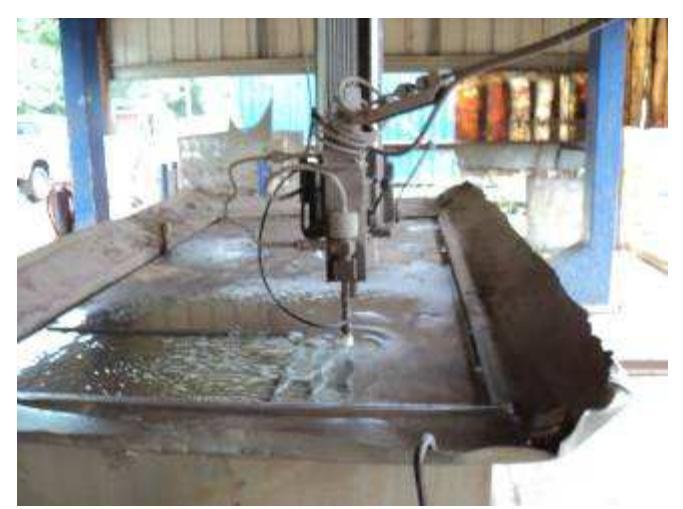
Figure 2: This machine can ca 0.1 mm accuracy, cut parts. Only water is used for plastics, rubber. Add to this mix abrasive, ie something like sand and water, stainless steel can be cut as with a knife.

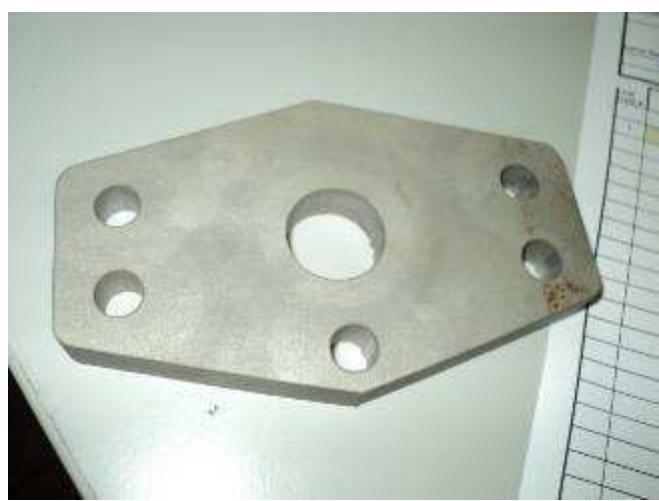
Figure 3: When they wanted to cut 10 such flanges, the holes were round.

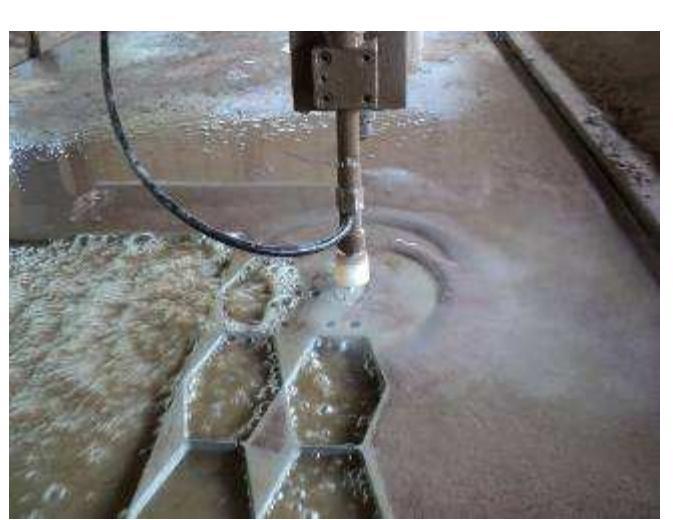
Figure 4: Within minutes are sol cut any contours. Deburring is not necessary, the edges are rounded.

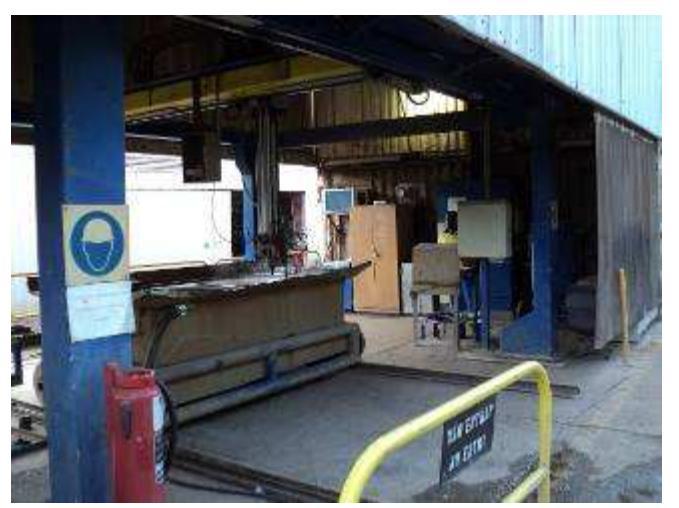
Figure 5: Now we have made the service because too much sand on the roller guide and the racks was driving, causing restless movements.

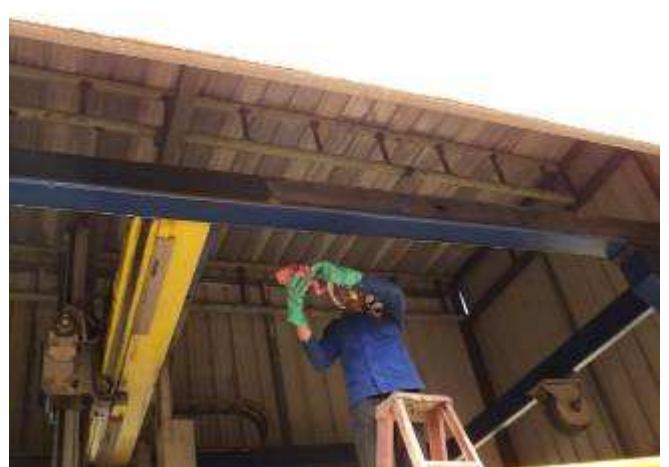
Figure 6: According to the provisions in the camp, the scaffolders must stand a scaffold because over 1.8 meters allowed to work from the ground only with scaffolding. If a scaffolders comes and the Machine is urgently needed, selects alternatives.

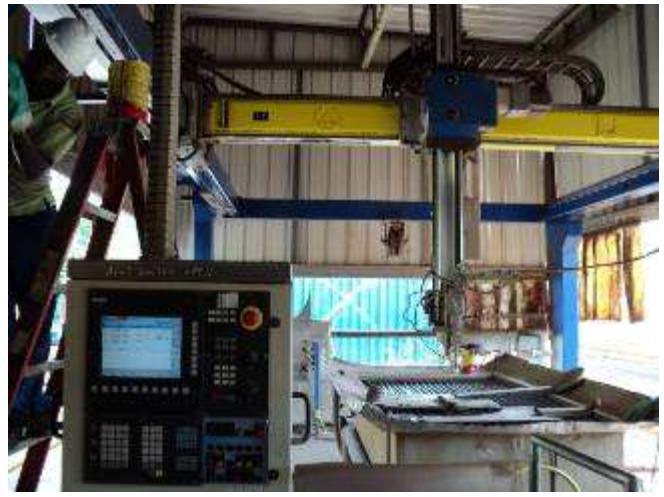
Figure 7: A day we need at such a machine for good cleaning and inspection.

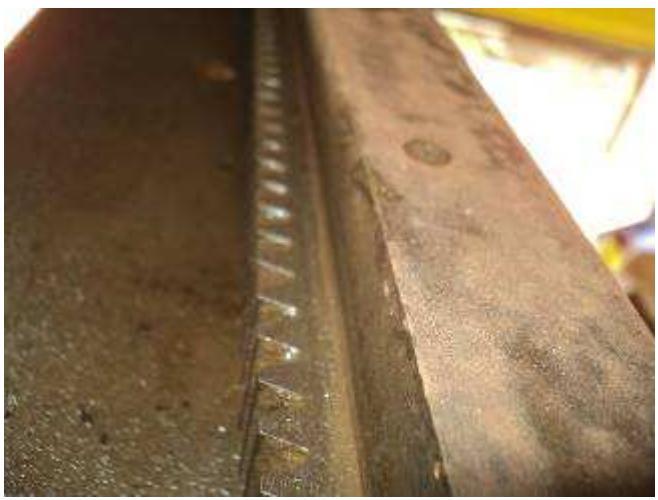
Figure 8: Here we see how the racks and guides look. Also, rust and sand cause irregular operation.

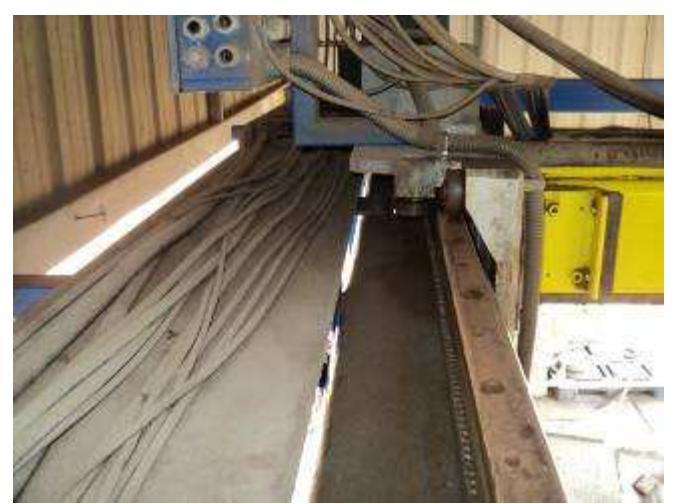
Figure 9: The fact that the sand and the water is unusual so injected around. Because from and work to less experienced people on the machine, can such a thing happen often.

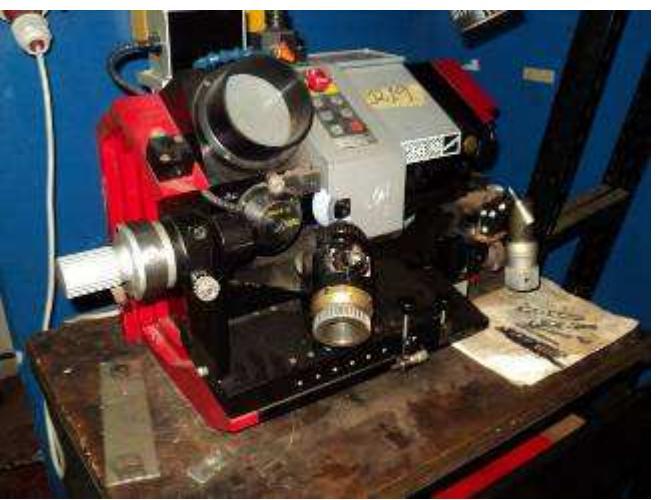
Bild10: This new drill grinding is a long time in the tool room. When we once wanted to make a test last, nor the drill shots were missing, but it has now been found. We now make test loops.

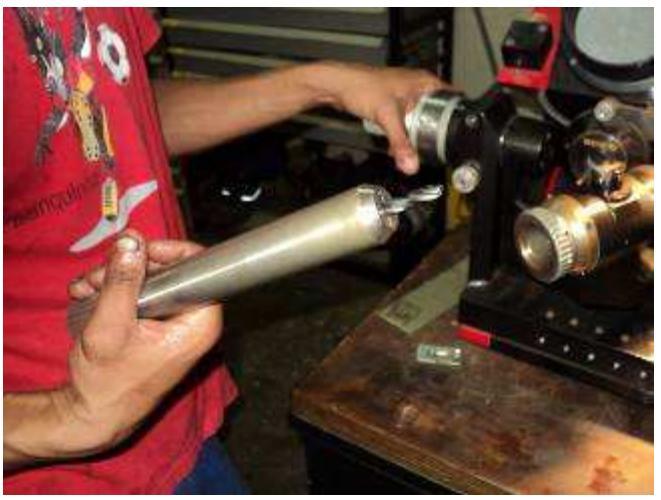
Figure 11: The drill bit is clamped in a chuck, then one can grind with 2 angle. identical first to 10 degrees both sides so that the center is true, then at 30 degrees.

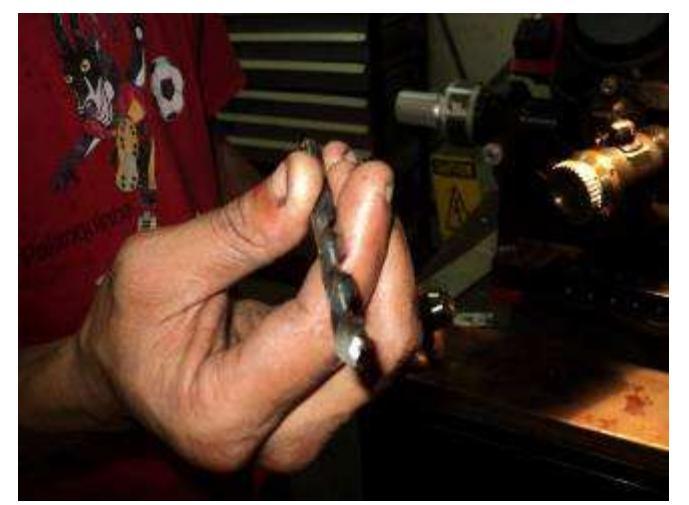
12: We have taken very bad drills to test soche were canceled

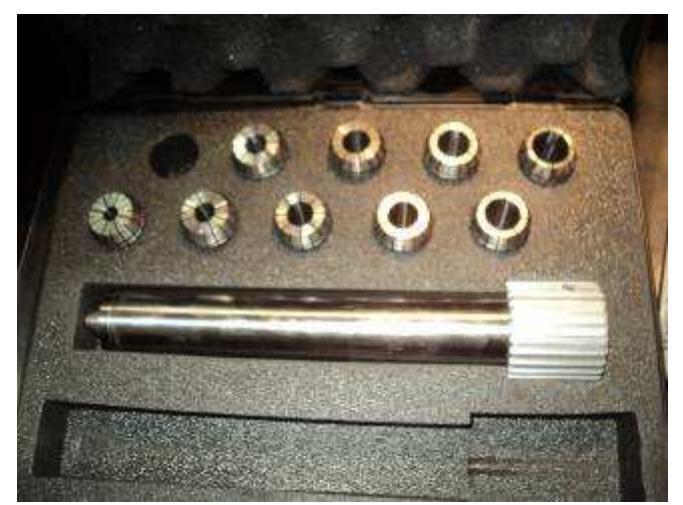
Figure 13: Here clamp the various grippers to drill. This machine can be used up to 20 mm and for cylindrical drill shafts.

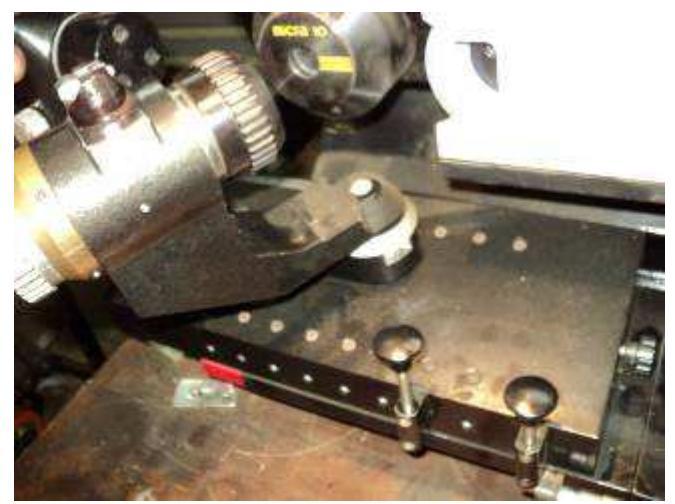
Figure 14. Here, the drill is clamped, so that it is horizontal on the line next to the optic at an angle and the 180 degree lock is locked. So both sides with 10 degrees can be geschliefen evenly.

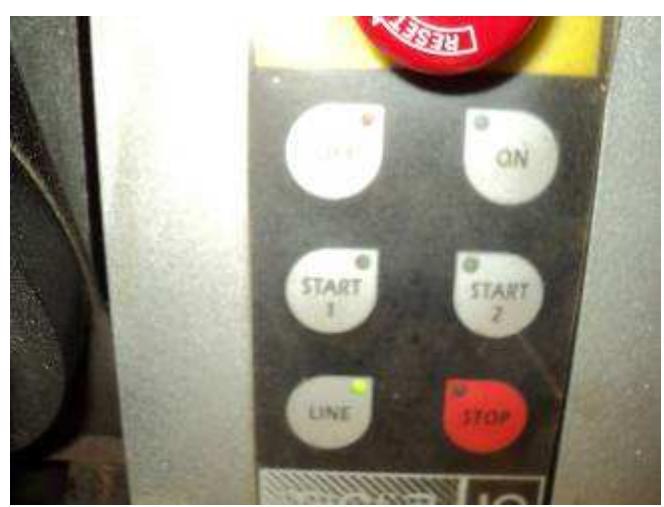
Figure 15. The machine has two grinding wheels

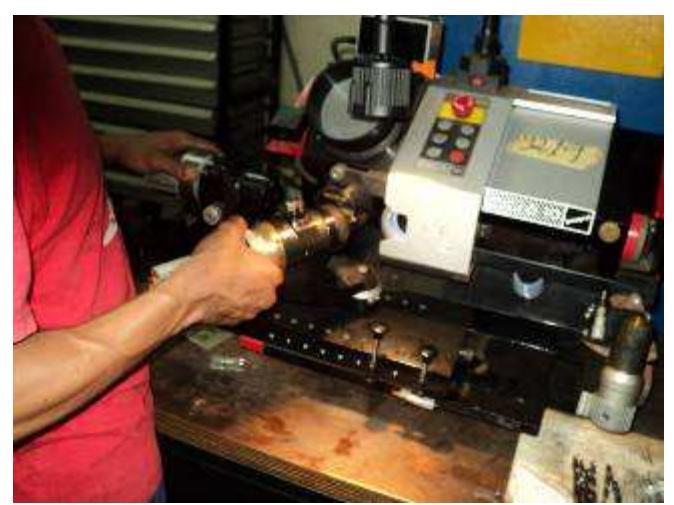
Figure 16: Carlo exercises and grinds until the drill "ok" is. We tested whether he drilled well and if the diameter is correct, it is good. Now people are trained by the "Machining". If they do not have enough work, then man is there, the drill can regrinding.

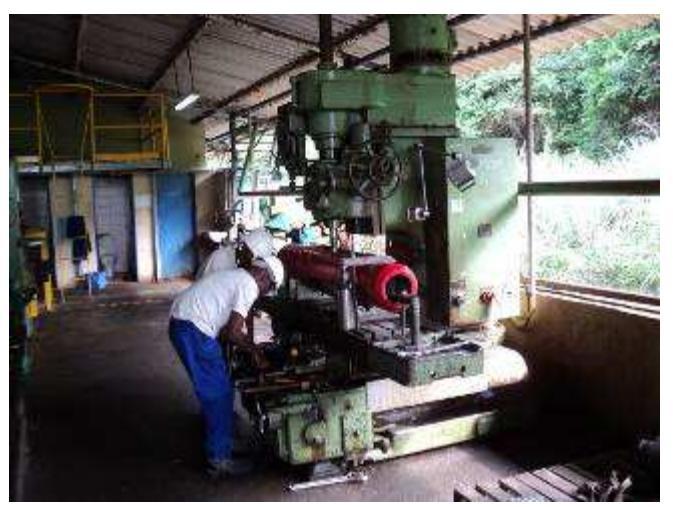
Figure 17: There was a message that no longer goes to the Hermann milling the feed. The feed gear box had to be opened.

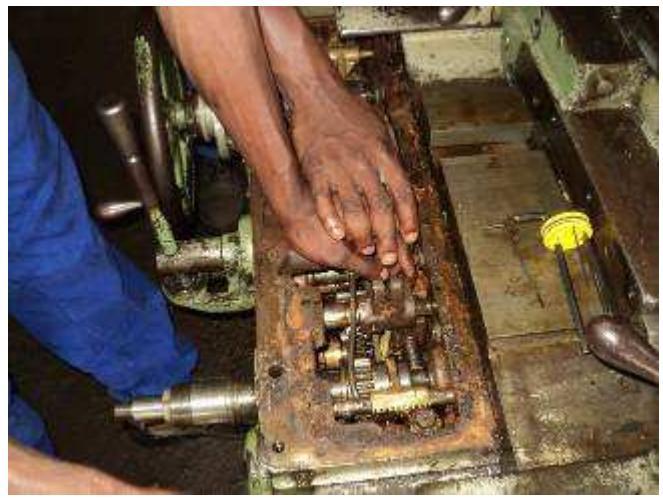
Figure 19: As the designers had to study even more than today, if you like watching a gearbox. Much shafts and gears and slide mechanism.

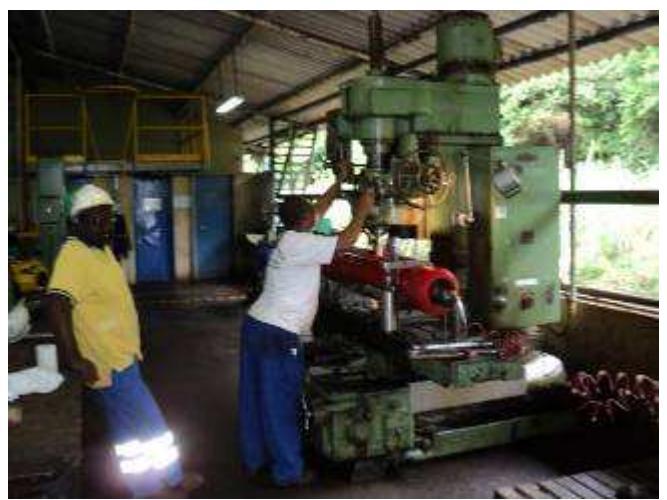
Figure 20: 3 hours later, the people of the "Machining" department can work on again.

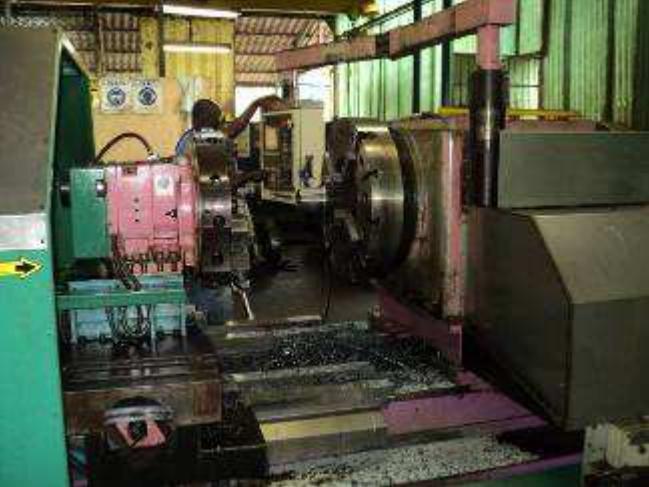
Figure 2: Here the Gornati WIAP DM4C lathe. She has a few years on the back.

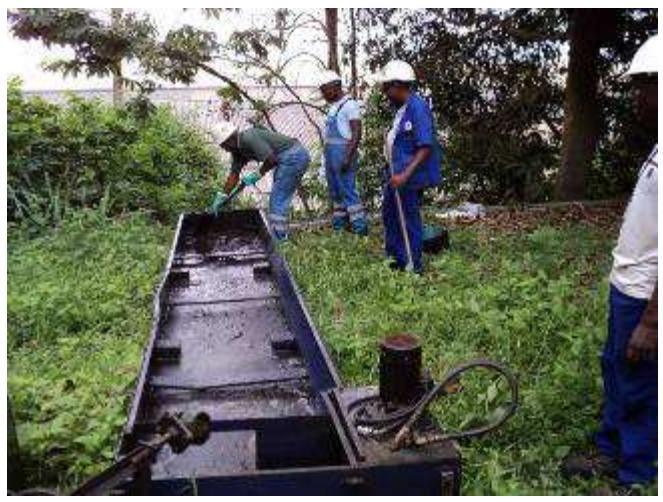
water below a relatively long standstill bacteria.

Figure 21: water tank cleaning.

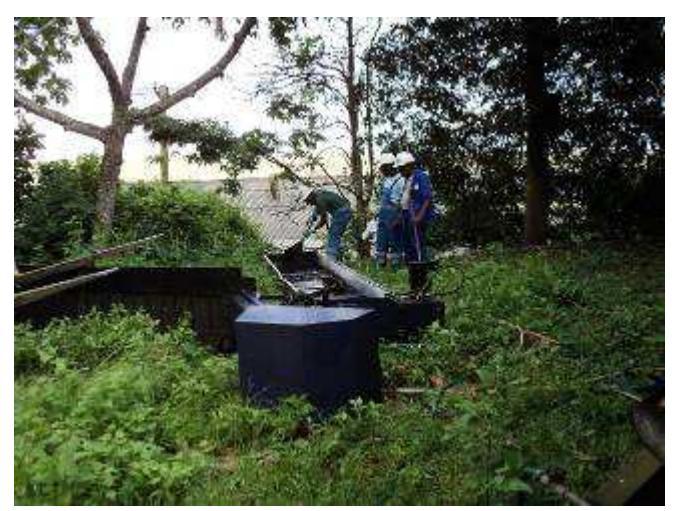
Figure 22: The emulsion stinks always lousy. Because the oil film of lubrication always up floating covered the water and makes the

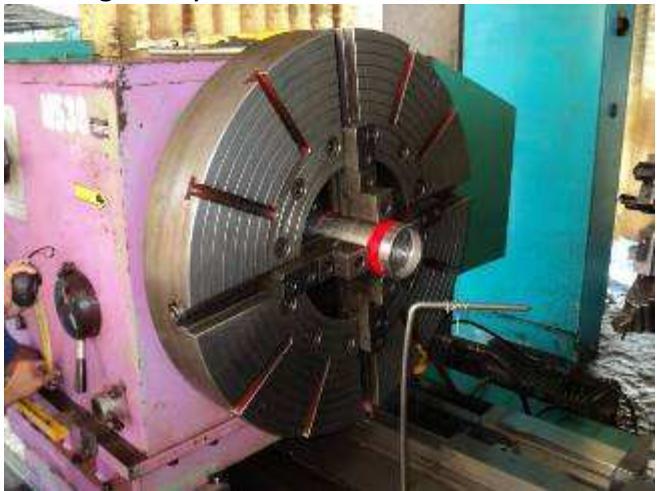
Figure 25: This is the brother of Gornati lathe Gurutspe. Only the headstock is from the old conventional machine. The bed and the carriage with revolver and CNC control is

something new (15 year). The CNC with the spindle and feed motors is new since of 2006.

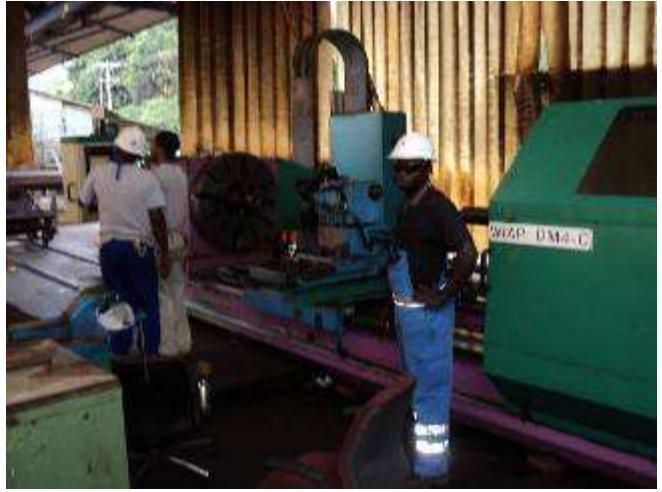
Figure 26: This Gurutspe WIAP DM4 C has the same machine bed and compound slide as the Gornati, but just the headstock of a Spanish machine

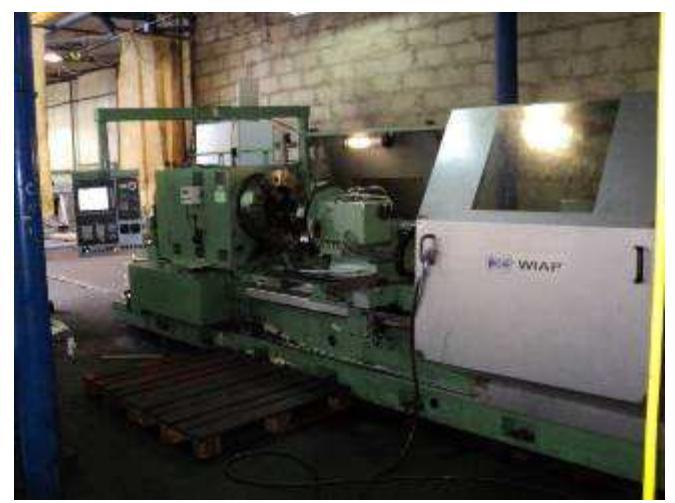
Figure 28: This is the Futji Seiki ex conventional lathe. It was rebuilt in 2007 to 2010 in Switzerland. There was no hurry, because the plan was umzuverlagern fabrication and then to place the machine directly to the new location. The move has, however, delayed until today.

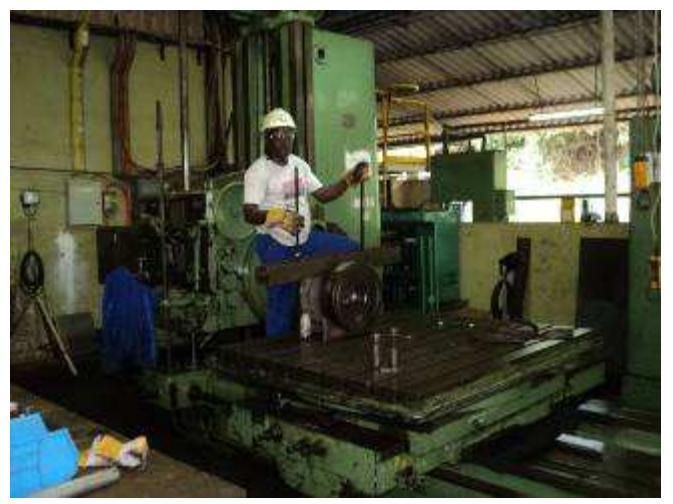
Figure 29: This old Union has built in 1950. This machine is taken once a year were examined in detail, so that spare parts can be ordered. If necessary, redesign to newer parts.

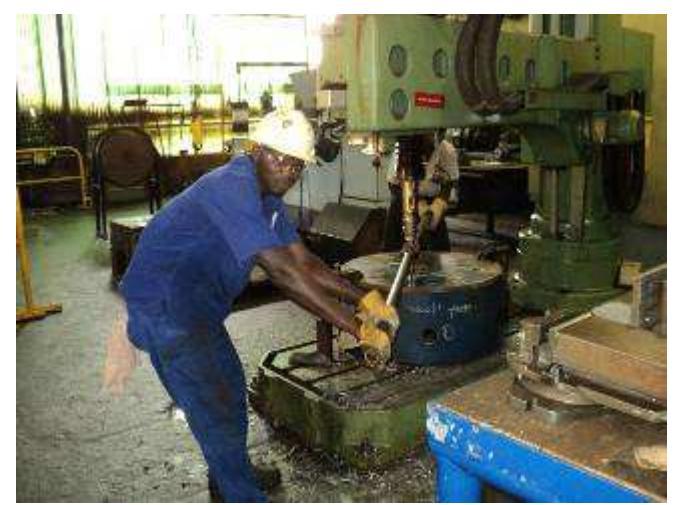
Figure 30: Cut For large thread belongs here at the Algoa everyday life. The people make it very conscientiously. As there use force.

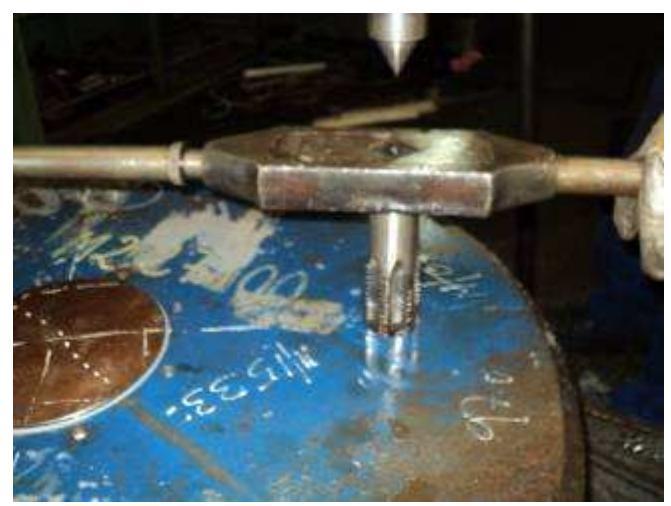
Figure 31: Every time the strong men turn the wrench is guided from above the tap. In order to reschedule the wrench, the hydraulic clamping of the machine must be released and re follow up. Obviously these people who work here, decades of experience; this will be noticed immediately. Actually watching a pleasure. It is also apparent that much knowledge come from Swiss apprenticeships and other countries. What these people know today is only to be admired.
