# Photo report wi\_8\_f\_2500\_Tripp 2

## 2015 Angola HPW

Photo Report 07:06. / 06.23.2015 "Hans-Peter Widmer"

### 1. Mega Bore CNC lathe

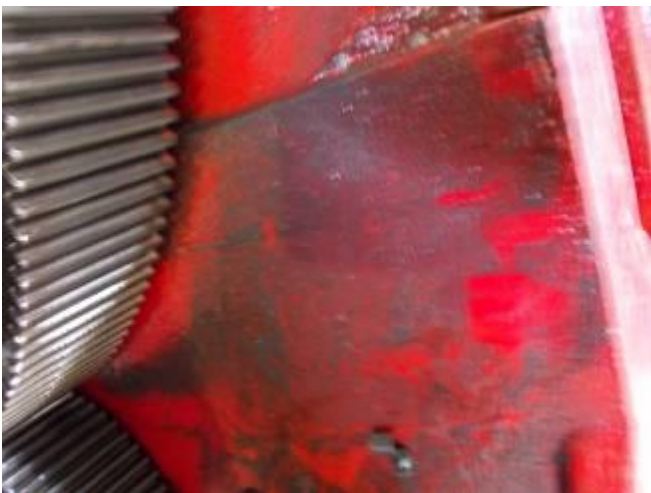
P7: The dirt abrasion

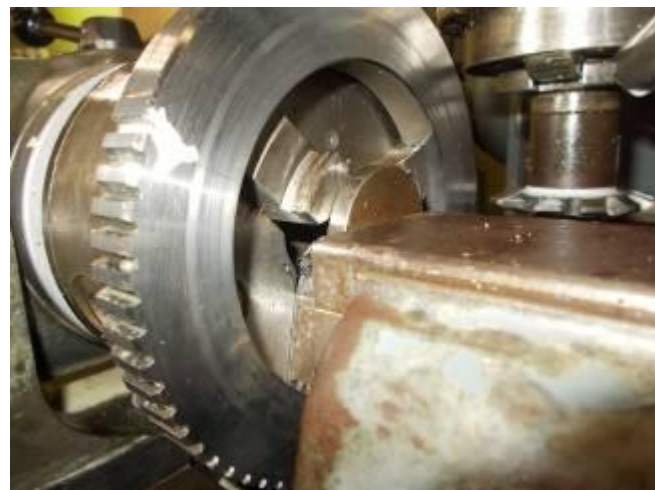
P38: the large gear is re-established. Unfortunately, with the module 2.5 mills, instead of the 2 module cutters. Here we have to gear training with the machine people. They do

not know that the diameter divided by the number of teeth, +2 teeth, the module outputs.

P39: Nevertheless gears can be made in Angola.

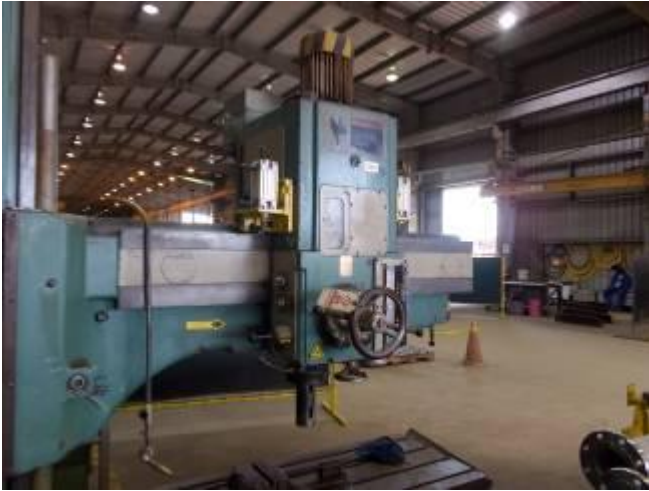
P60: The deep hole drilling machine "TBT TIBO" lost per day several liters of hydraulic oil in the working oil. It had to be dismantled 2 sled. Doing some maintenance work could also be made equal.

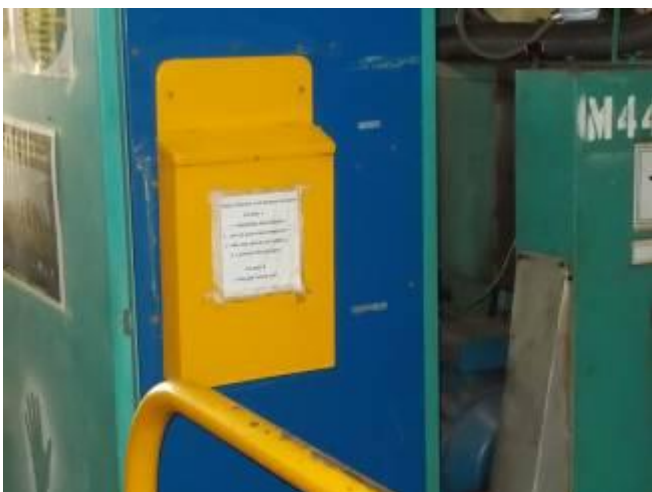
P68: This yellow boxes could tell stories. Since about 2008 applications.

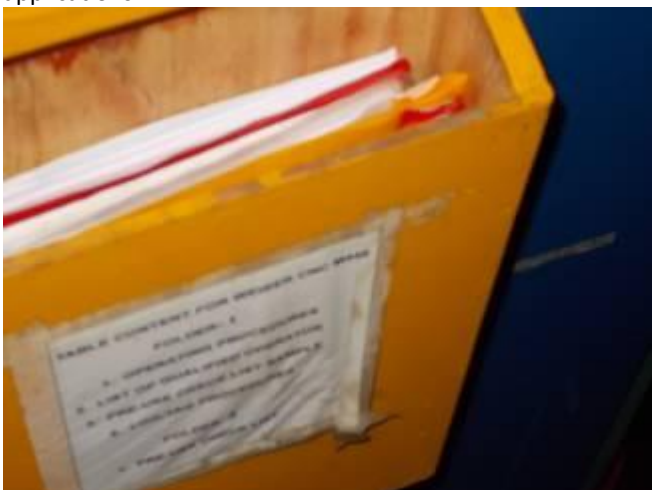
P69: Short Manual. Service Instructions, etc. A good thing. The machine mailbox.

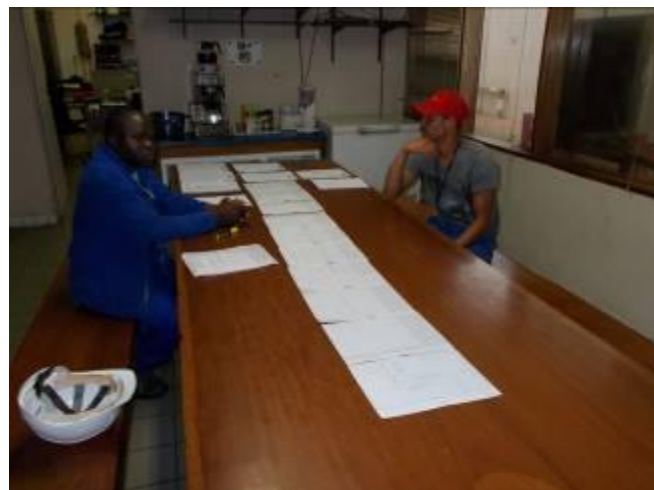
P71: Here is the new documents will hergerichet for July 2015-June 2016

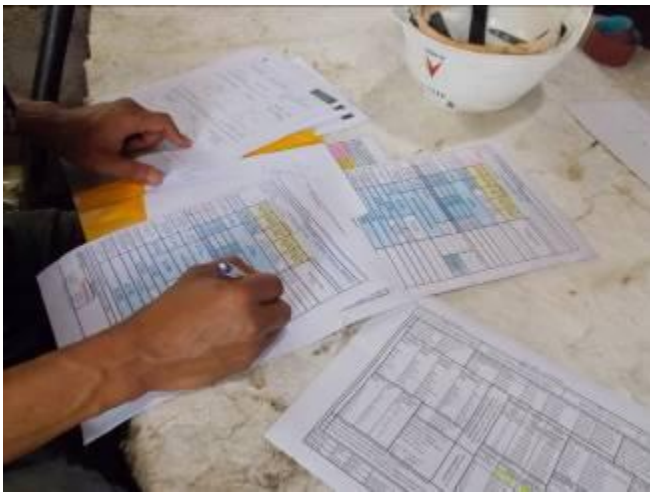
P73: For Vam the logs are filled

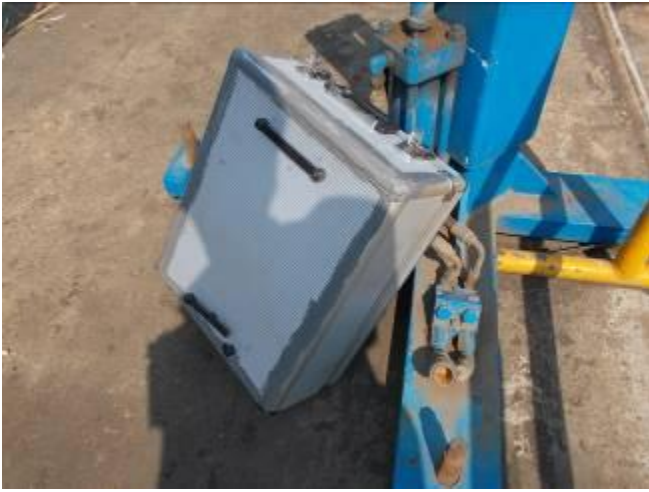
P79: Alberto had to stick everything.
