Picture report. Angola Trip1 - 4, 2014. report Summary

Conversion CNC lathe Mega Bore

Title: WIAP maintenance program
MEMV of everyday life report

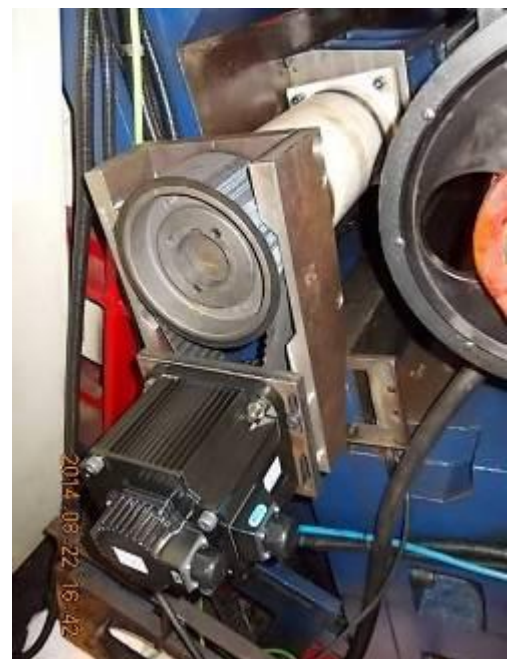
Figure 11) This solution makes the handling flexible.

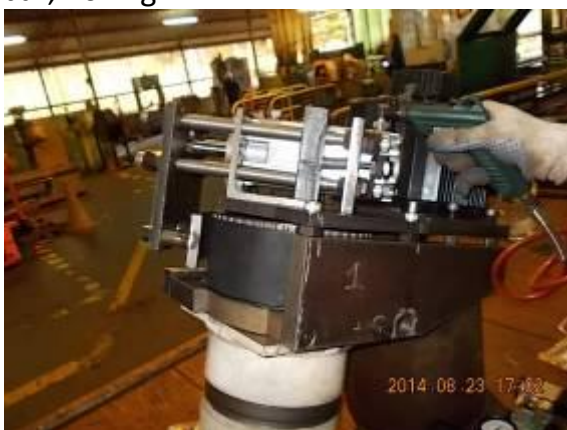
Image 9) A braking test on the workbench

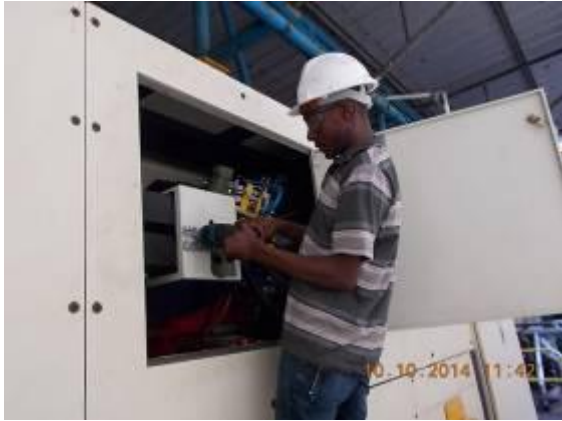
Image 11b) Yoba in the terminal box of the Z axis herrichten.

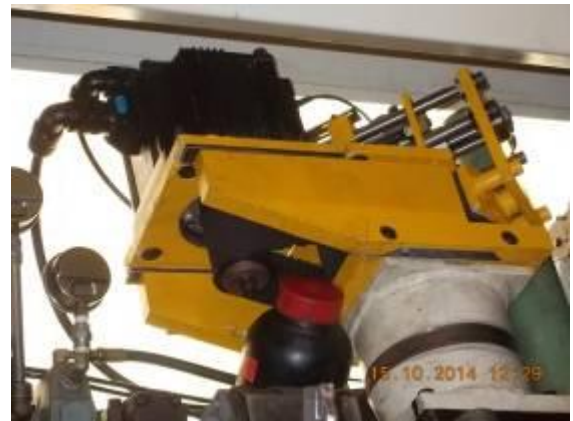
Figure 15) The newly grown X spindle feed drive.

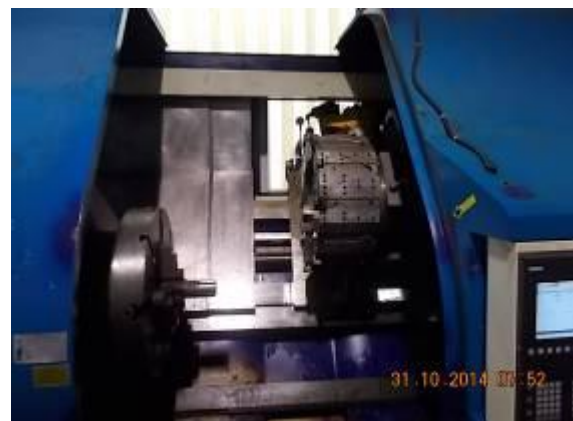
Figure 16) The Mega Bore CNC Lathe. New with the Sinumerik 802D sl CNC control.

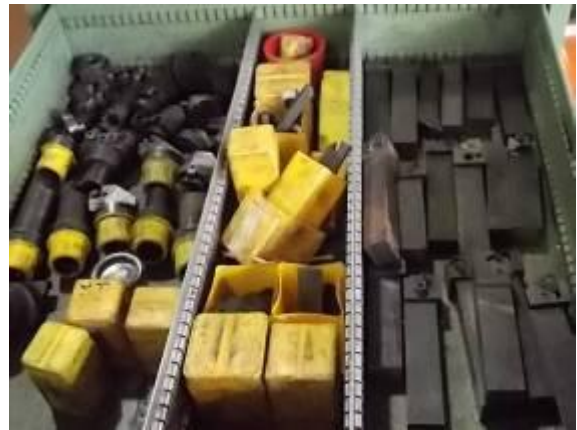
Figure 21) After:

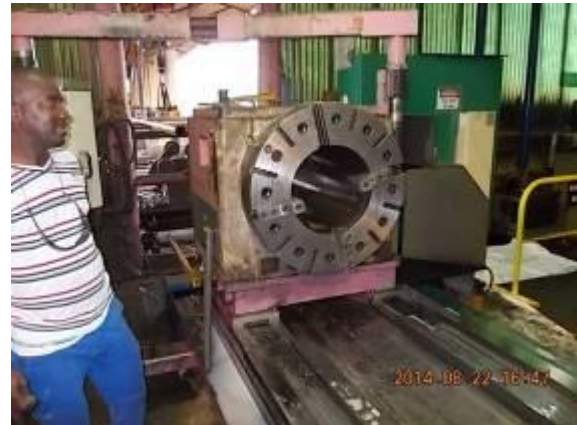
Figure 25) Links Alberto, our maintenance man Malembo.

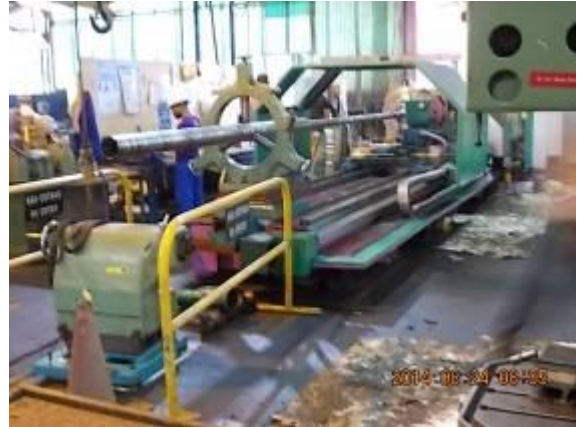
Figure 31) The wave looks safe 2 meters beyond the machine. The tailstock had to be taken away.

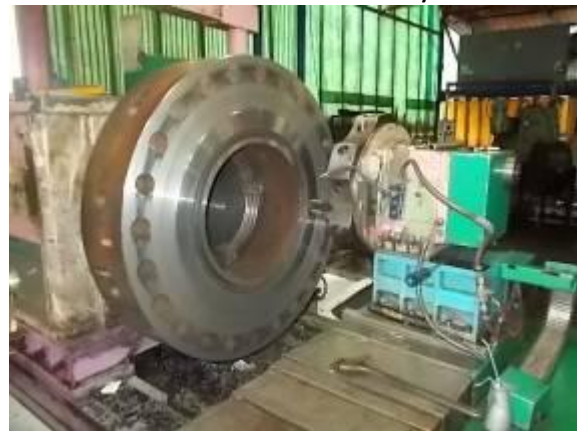
Picture 31a) As soon repaired the food, all the workpiece sizes come back to that machine. Often the machine works day and night.

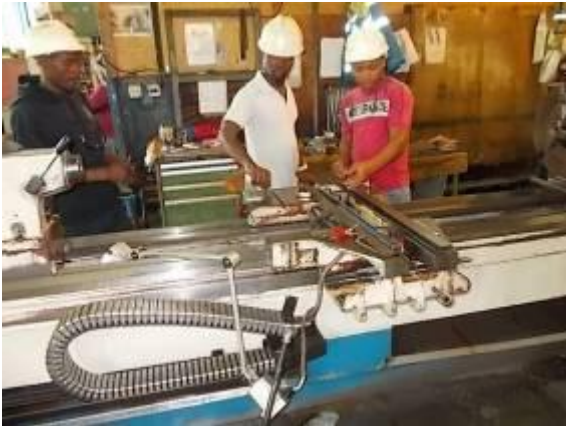
Figure 33) Throughout the slide we had to take down, because the lubrication pump stopped going and we wanted to know the cause.

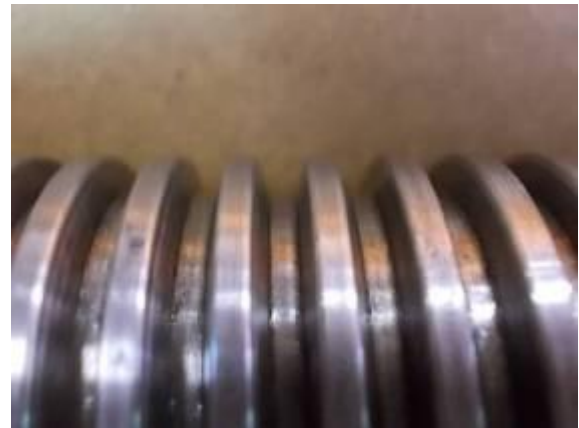
Figure 35) This is how the spindle from behind

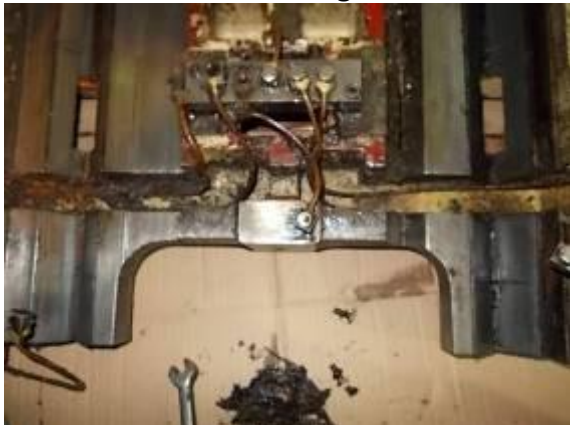
Figure 39) The compound slide down a lot of dirt.

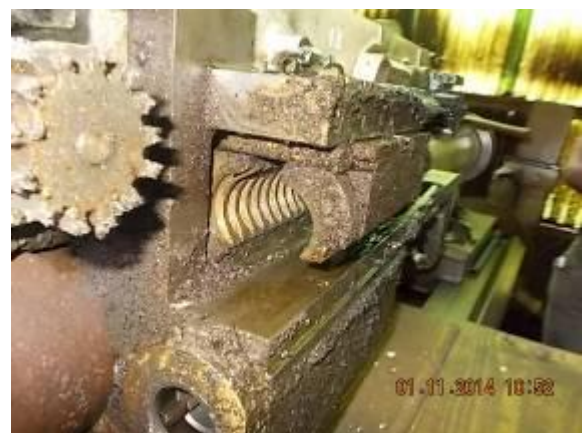
Figure 50) If three times is a mistake to be traded.

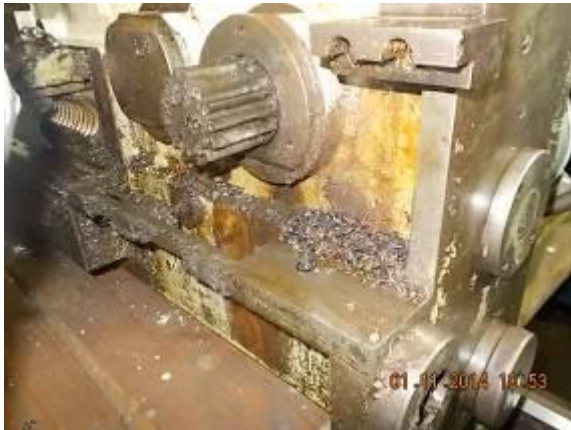
Figure 51) was the cross slide dismantled the error to see.

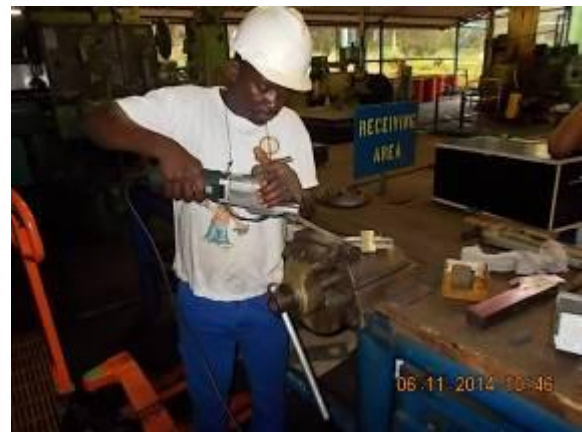
Figure 54) Since this work is very delicate, the maintenance people first had to make a test on a test piece, with the electric shaving machine Biax. Alberto when scraping.

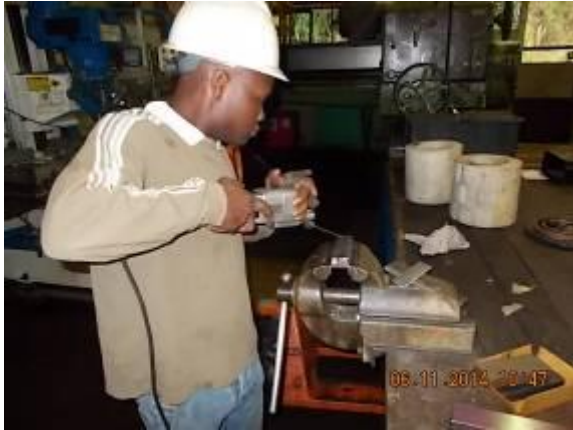
Figure 55) Antonio when scraping

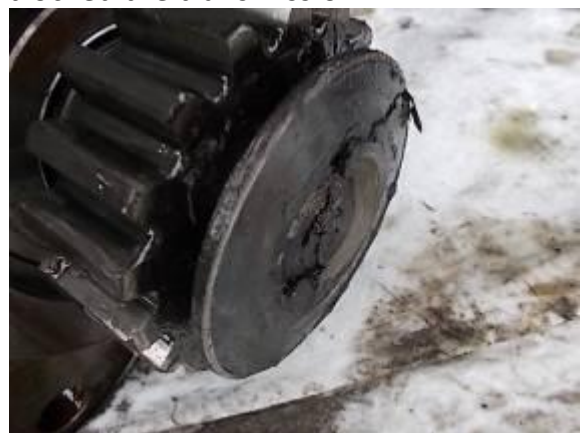
Figure 59) migrated little in the transmission.

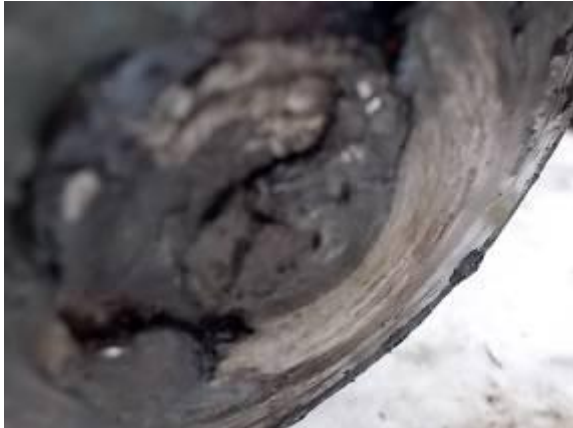
Figure 63) Some damaged areas.

Figure 60) a friction weld in the transmission

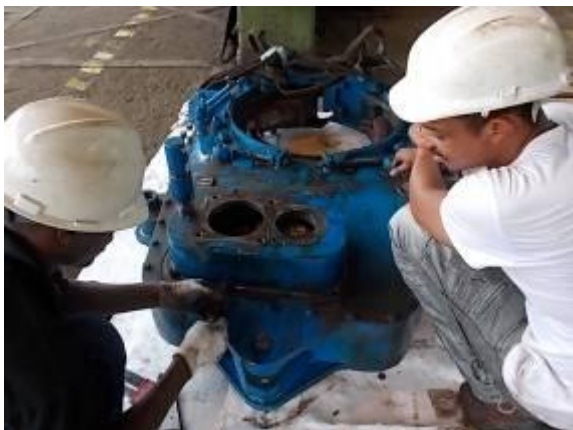
Figure 64) with large extensions had to be opened some of the screws.

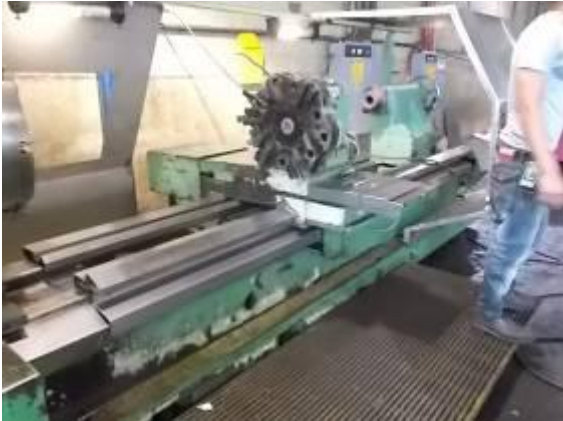
Figure 74) Just days machine downtime and let the rust is there.
